Vehicle information			
Make:	HONDA	License:	RX4401
Gearbox:		Body color:	
Model:	HONDA E	VIN:	JHMZC7840MX201745
Fuel type:		Power:	113 kW
Version:	HONDA HONDA E 35.5 KWH ADVANCE 17 INCH	First registration	10/06/2022
Mileage:	33024 km	N° of doors:

Damage summary		Total Net Cost (exVAT) 0.00 EUR
Left	1	Right1

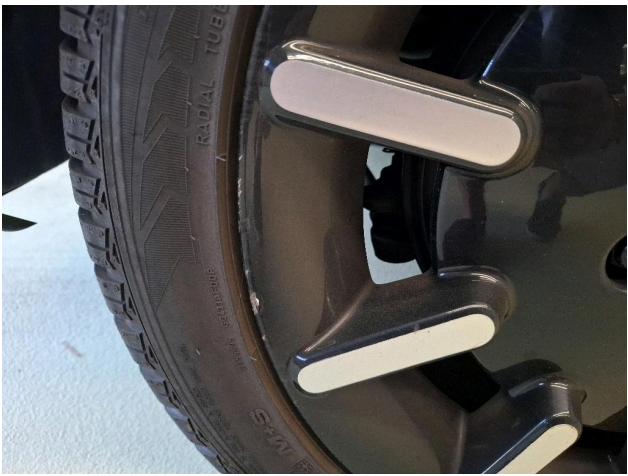
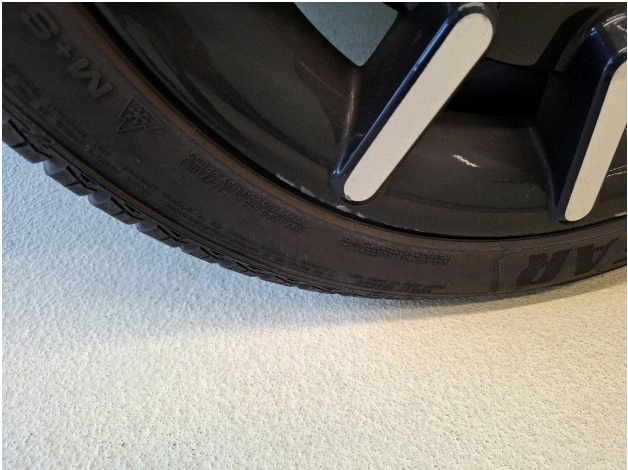
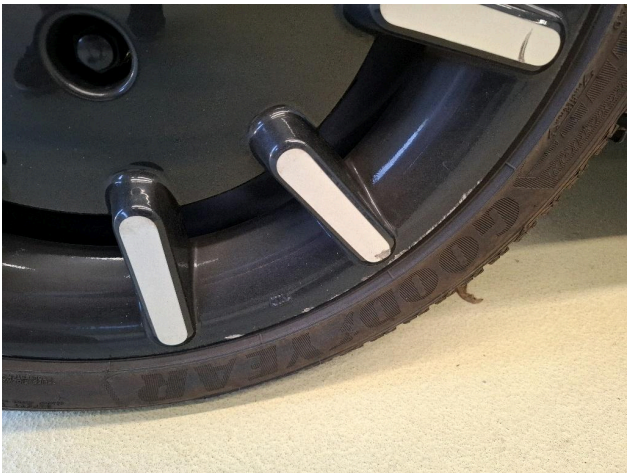
Alloy rim RR

Scratch(es)

Right

Net Cost 0.00 EUR

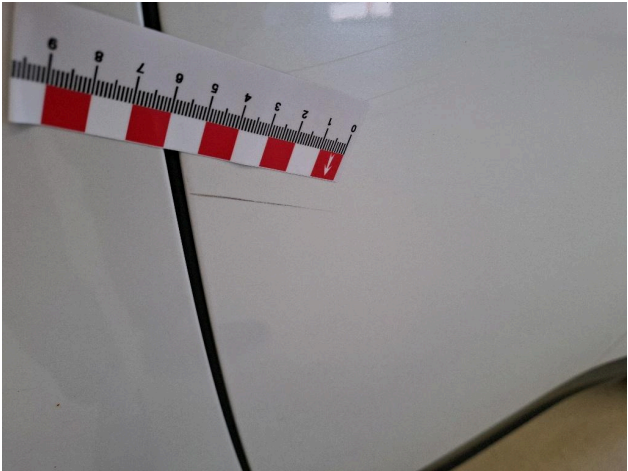
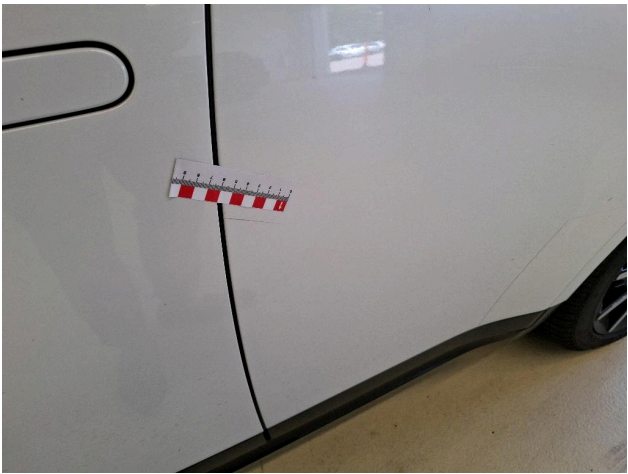
Door RL

Scratch(es)

Left

Net Cost 0.00 EUR
