## HYUNDAI Nexo Nexo VIN NO KMHJ8816FLU006392

### **Inspection Report Summary**

Customer BCA Online Report Number P20250512093550

Inspection Date / Place 2025-05-12 / BCA Oberndorf Cosmetic Grade 2

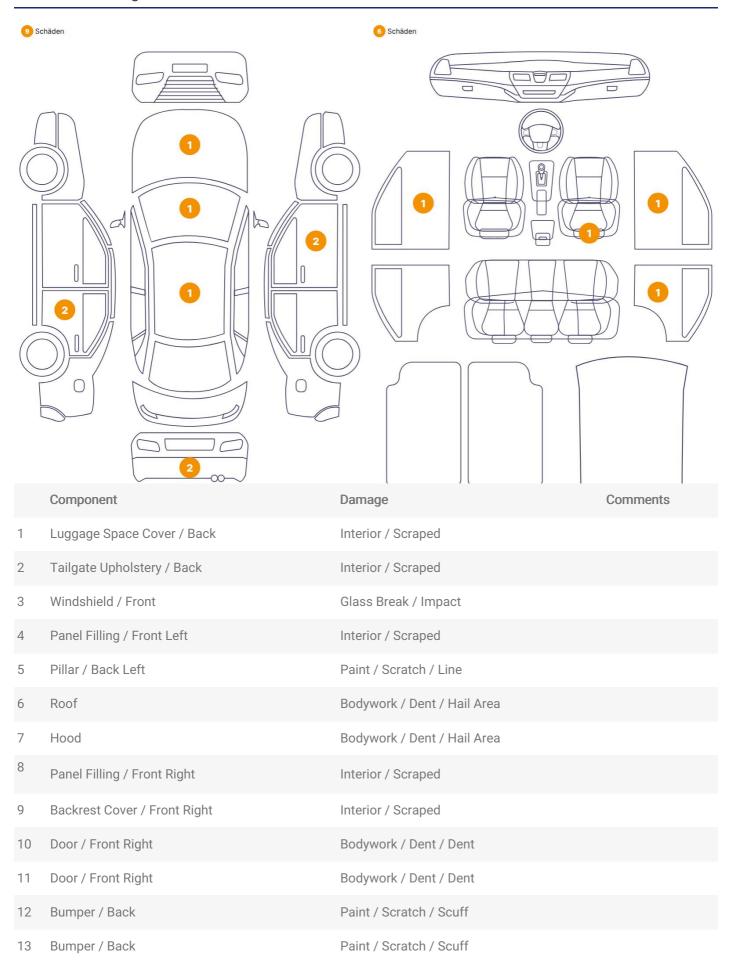
14	Door / Back Left	Paint / Scratch / Scuff
15	Interior door handle Back right	Interior / Scraped

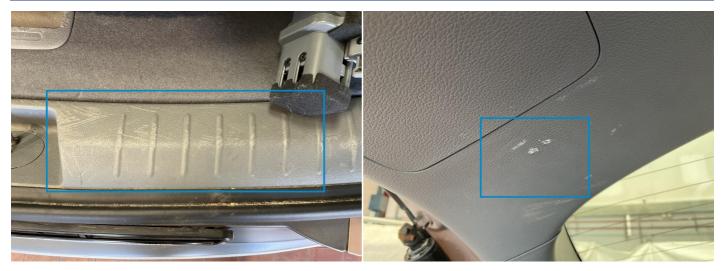
1. Luggage Space Cover / Back Interior / Scraped -

2. Tailgate Upholstery / Back Interior / Scraped -

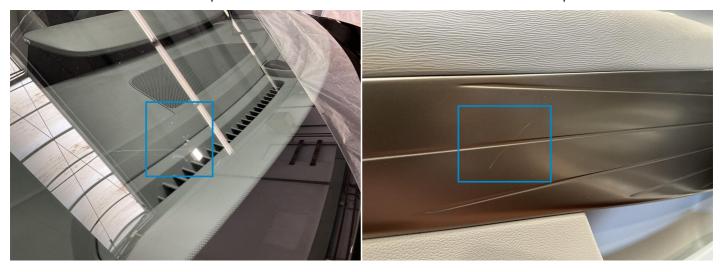
3. Windshield / Front Glass Break / Impact -

4. Panel Filling / Front Left Interior / Scraped -

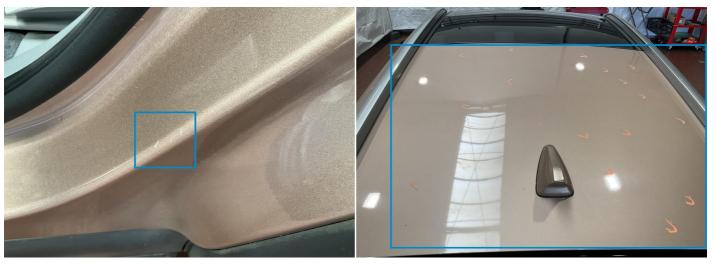
5. Pillar / Back Left Paint / Scratch / Line -

6. Roof Bodywork / Dent / Hail Area -

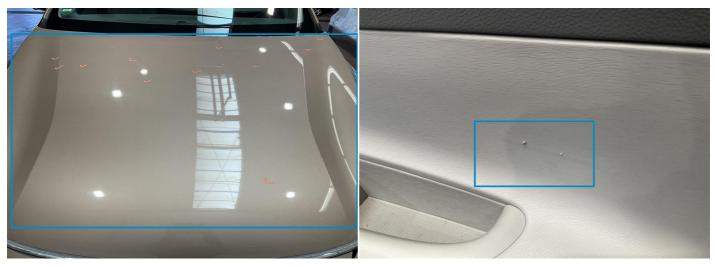
7. Hood Bodywork / Dent / Hail Area -

8. Panel Filling / Front Right Interior / Scraped -

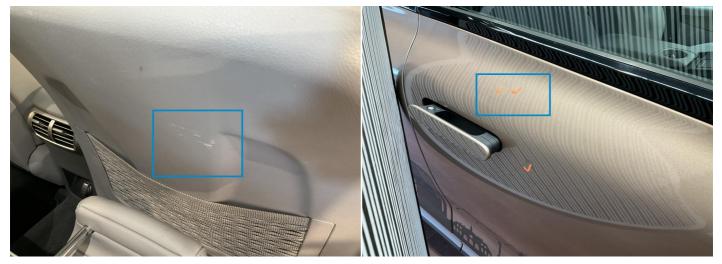
9. Backrest Cover / Front Right Interior / Scraped -

10. Door / Front Right Bodywork / Dent / Dent -

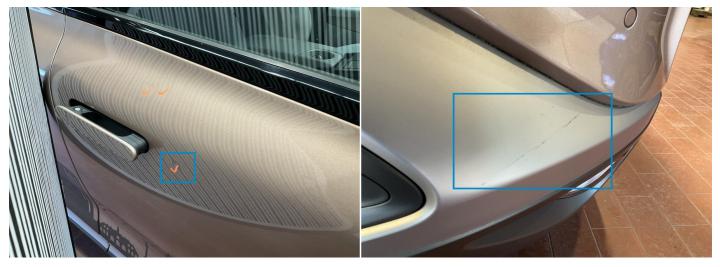
11. Door / Front Right Bodywork / Dent / Dent -

12. Bumper / Back Paint / Scratch / Scuff -

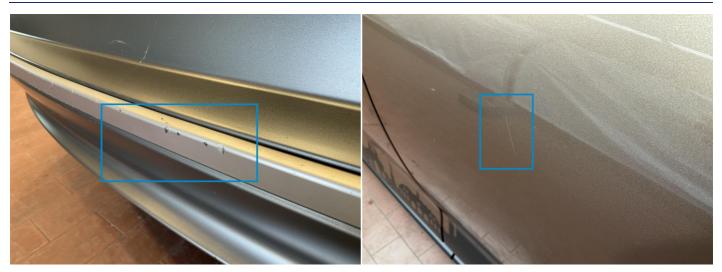
13. Bumper / Back Paint / Scratch / Scuff -

14. Door / Back Left Paint / Scratch / Scuff -

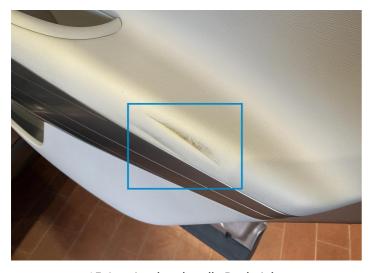
15. Interior door handle Back right Interior / Scraped -
