Expertise

Protocol number: 39835206
Order No. / Reference: 24759114
Inspection date: 20 May 2025

Manufacturer: Tesla

Model: Model 3 Standard Reichweite Plus Hinterradantrieb

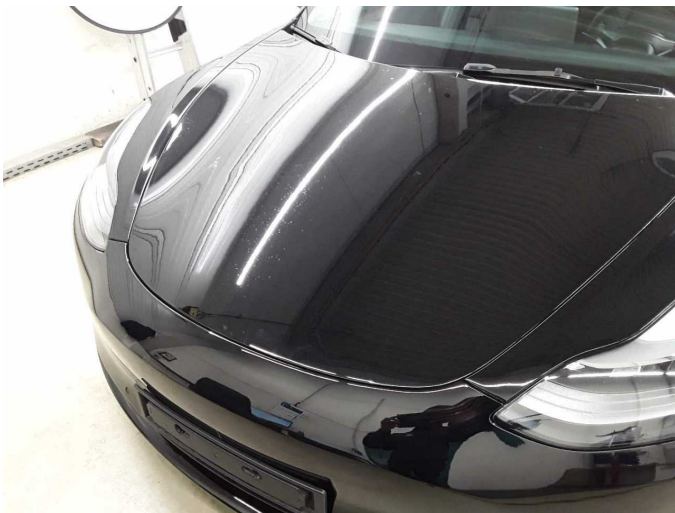
No.	Component group	Description
1	Misc.	Main inspection - No evidence - No deduction
2	Misc.	Inspection / maintenance - No evidence - No deduction
3	Bonnet	Emblem - Missing - Replace

Damage 3: Bonnet: Emblem - Missing - Replace

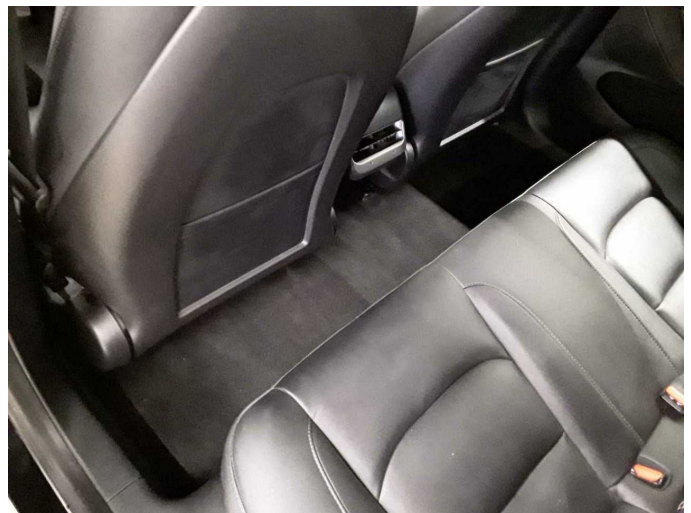
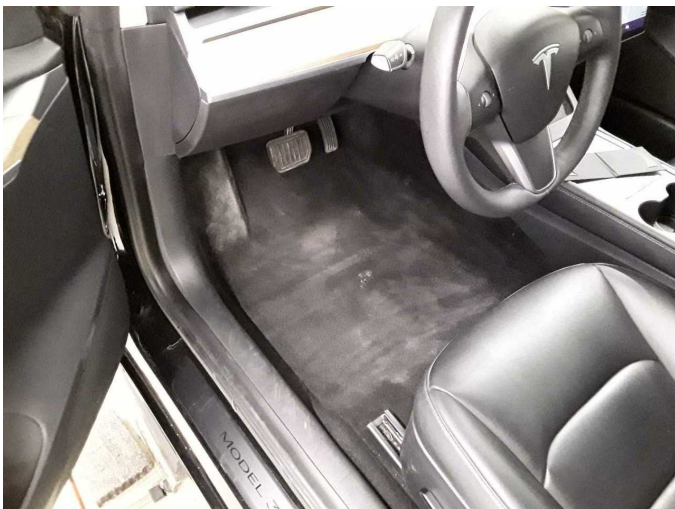
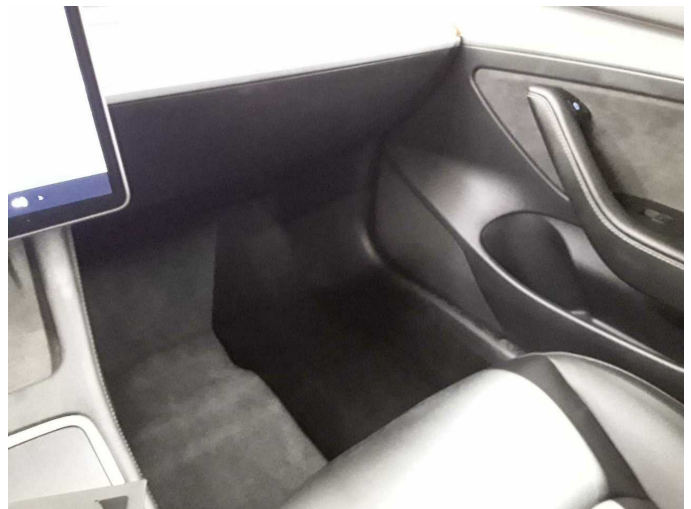
Trim / covers - Floor mats (Stoff)

Missing part 1: Trim / covers: Floor mats (Stoff) - Missing - Replace

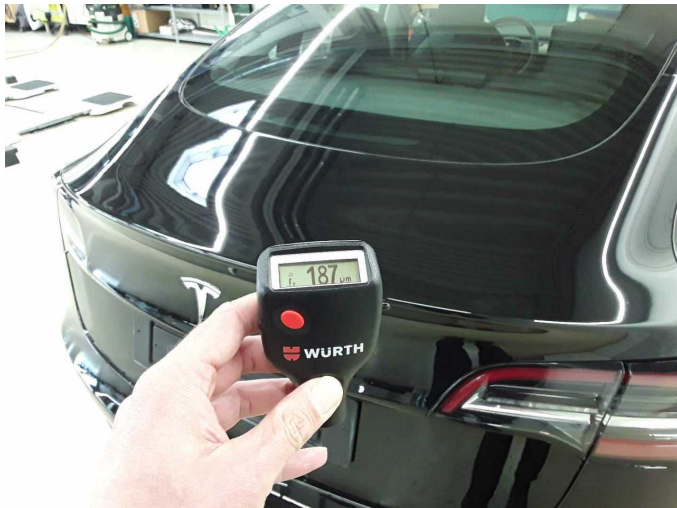
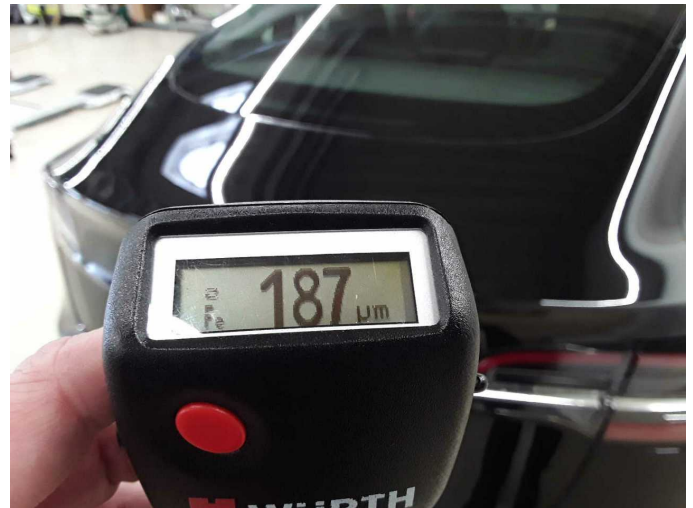
1	Boot lid / rear door, Mudguard - left side, Mudguard - right side, Bonnet, Side panel - rear left side, Side panel - rear right side, Door - rear right side, Door - front right side, Professionally carried out
---	---

Boot lid / rear door: 187 µm

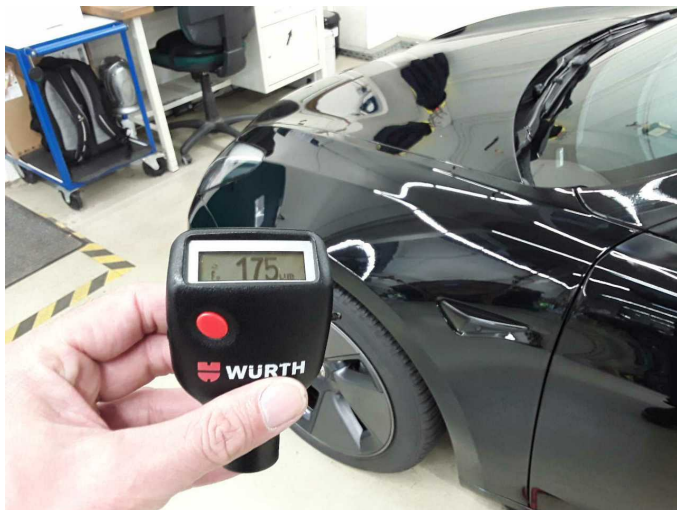
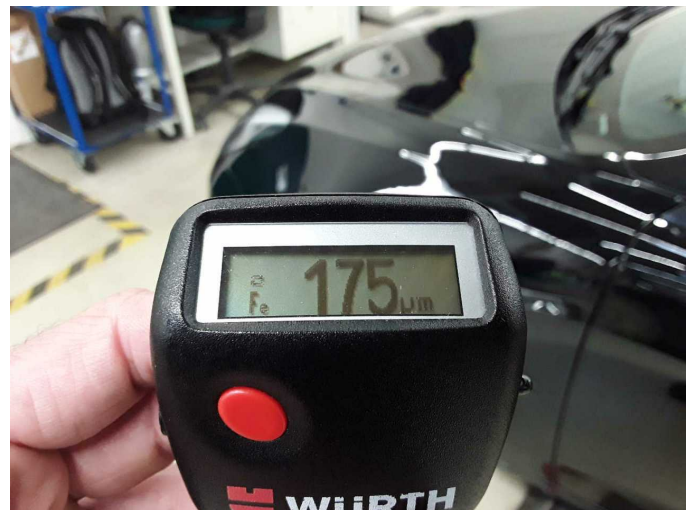
Mudguard - left side: 175 µm

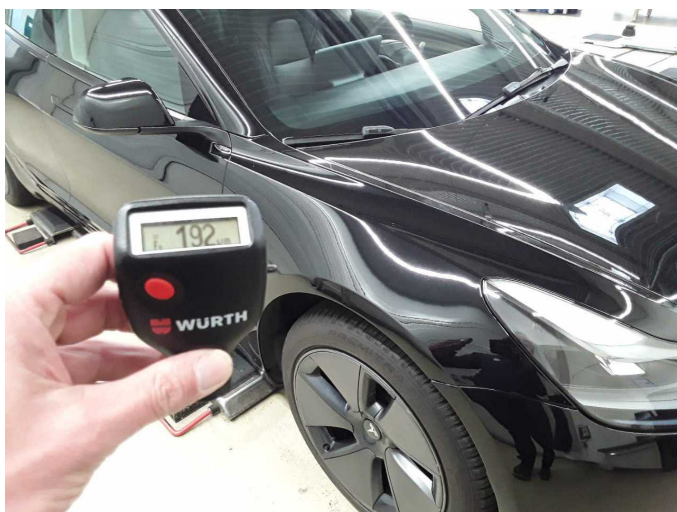
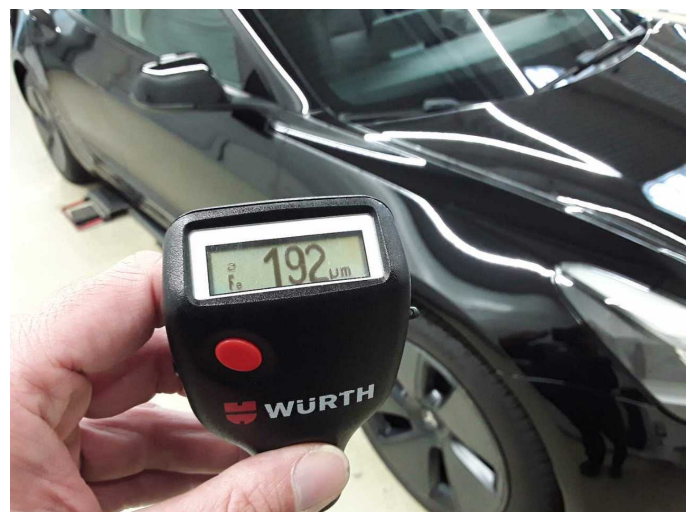
Mudguard - right side: 192 µm

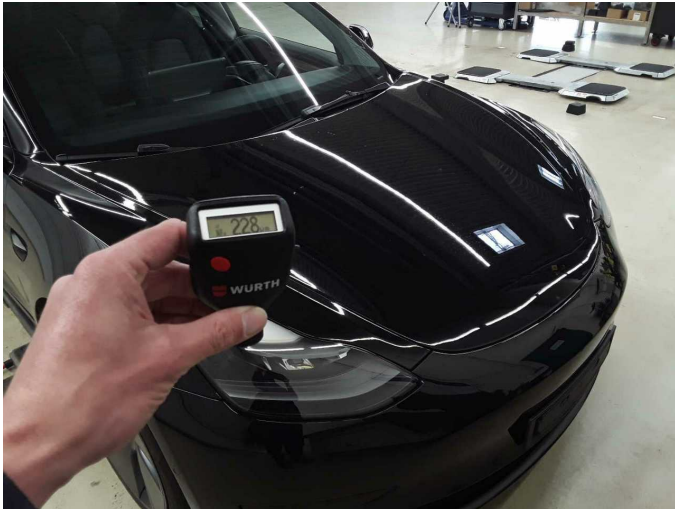
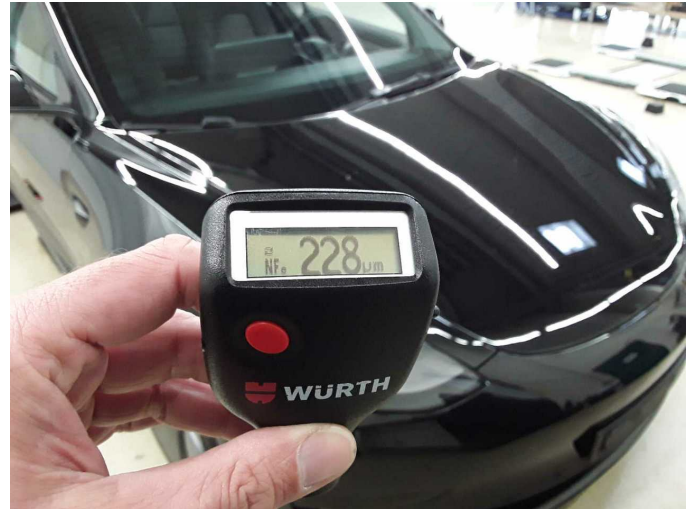
Bonnet: 228 μm

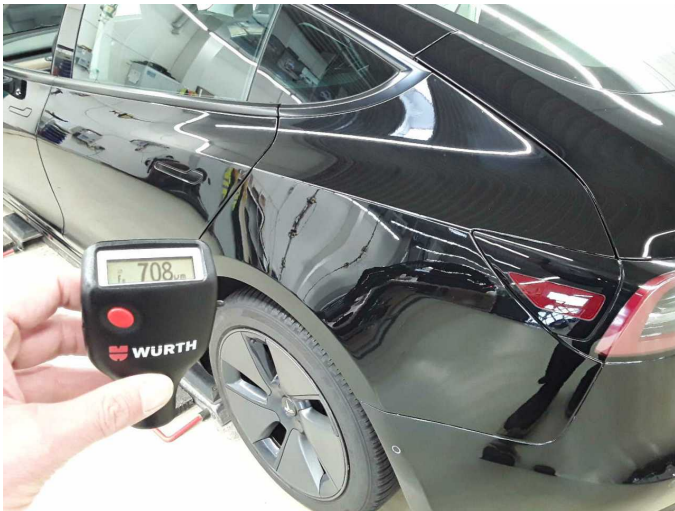
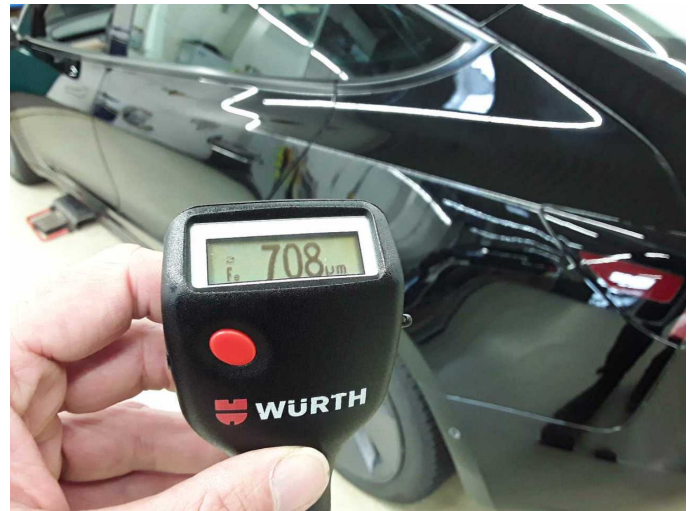
Side panel - rear left side: 708 μm

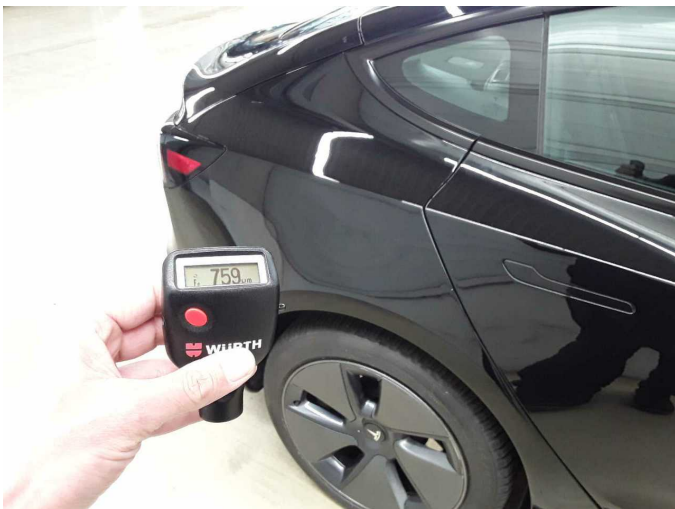
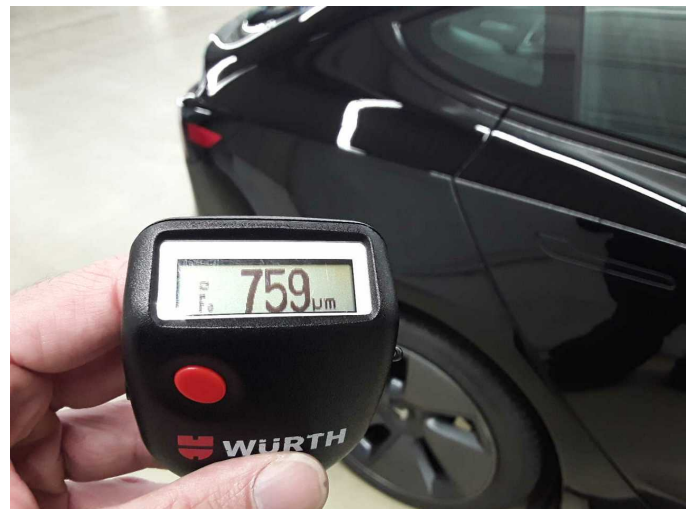
Side panel - rear right side: 759 μm

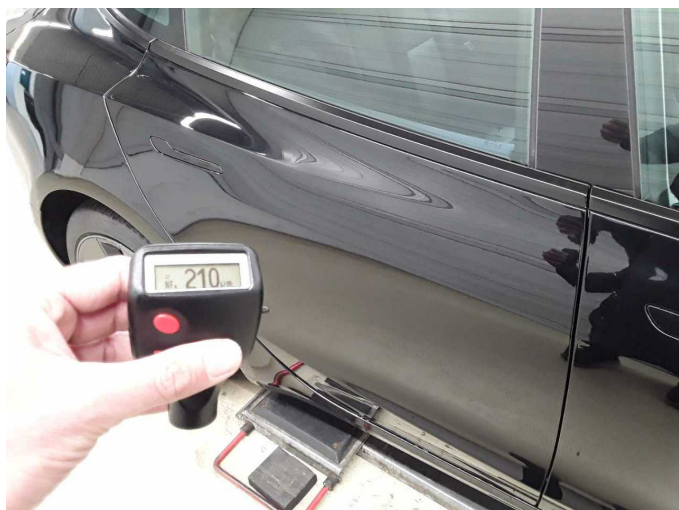
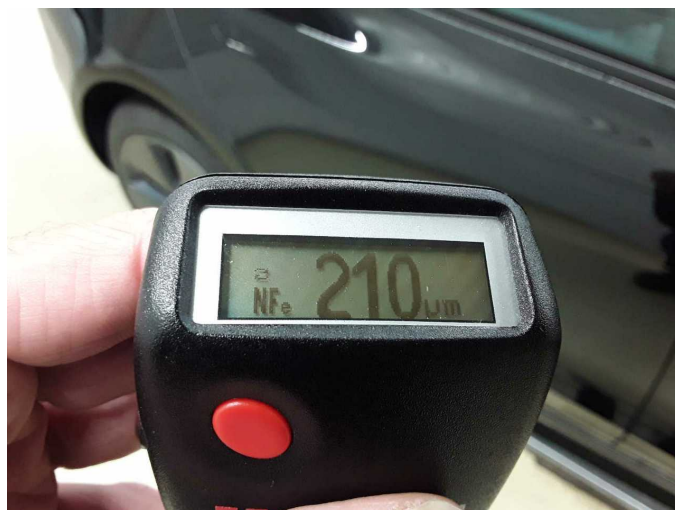
Door - rear right side: 210 µm

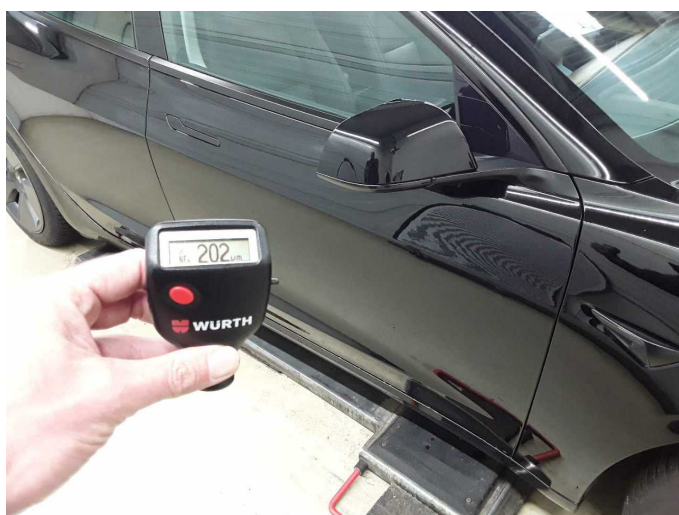
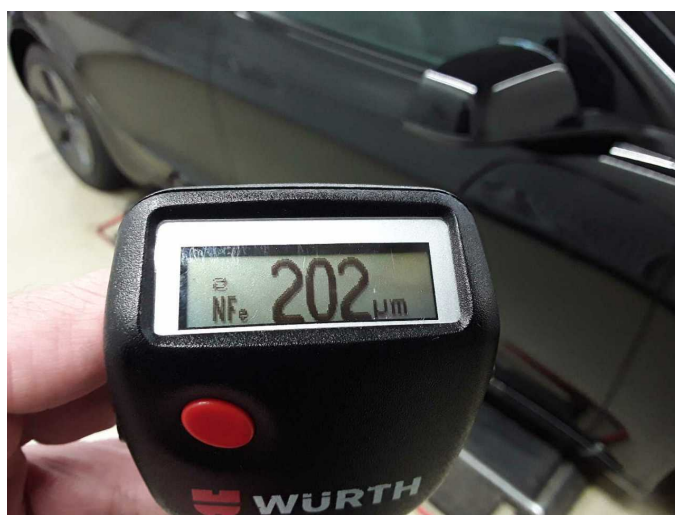
Door - front right side: 202 µm
