Expertise

Protocol number: 39745791  
Order No. / Reference: 24606927  
Inspection date: 15 May 2025

Manufacturer: Peugeot	Model: 508 SW Hybrid 225 e-EAT8 GT
VIN: VR3F4DGZTMY551925

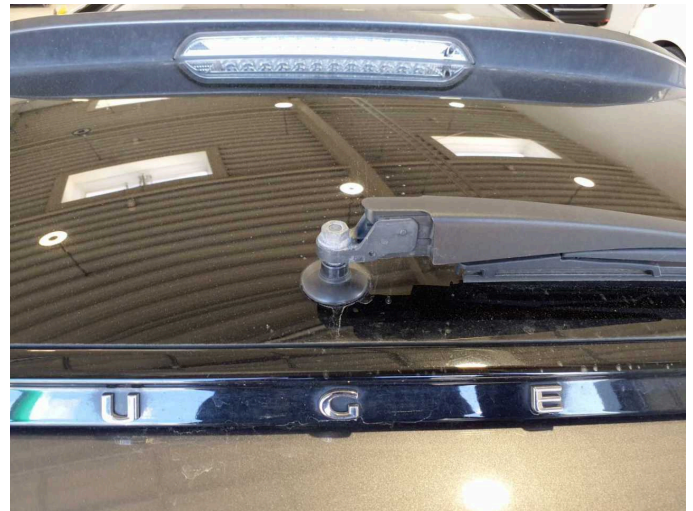
**Damage 2:** Screen cleaning: Wiper arm - rear (Abdeckung) - Missing - Replace

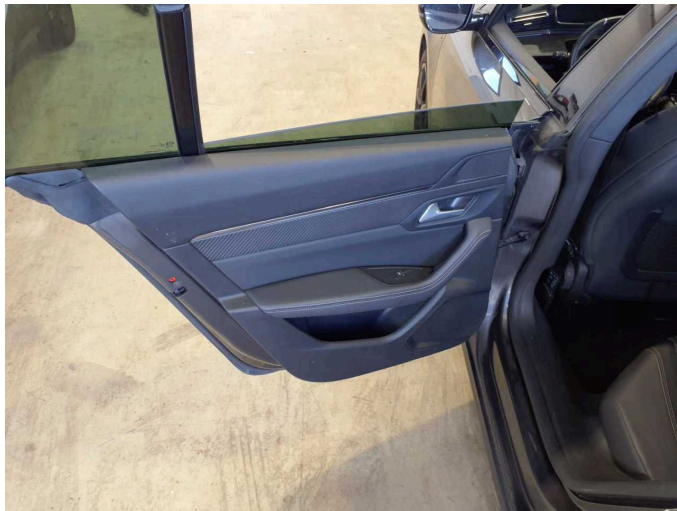
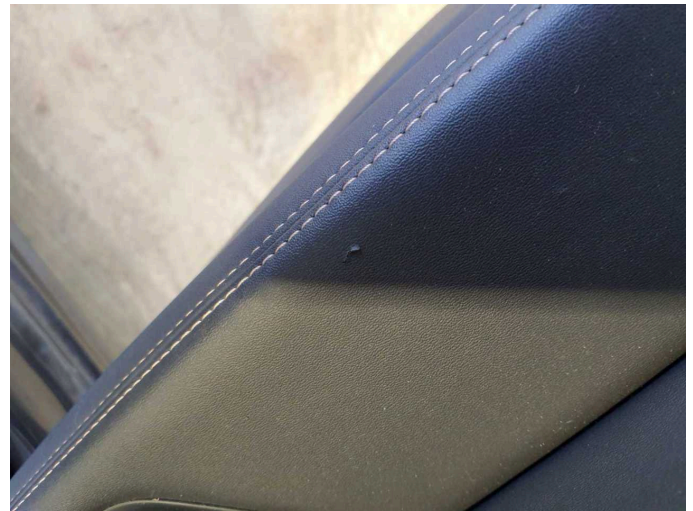
**Damage 3:** Trim / covers: Door trim - rear left side - Scratch(es) - Loss in value

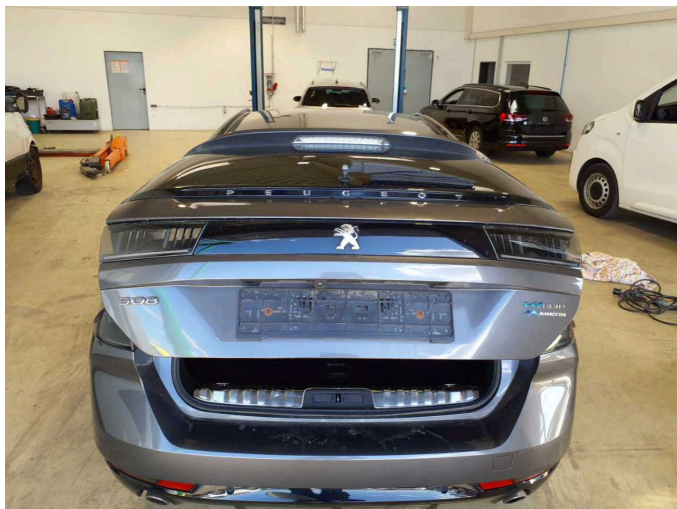
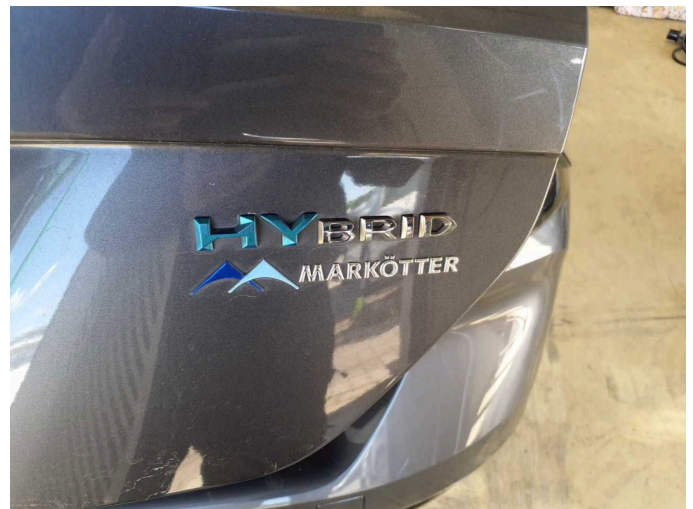
**Damage 4:** Boot lid / rear door: Boot lid - Glued / labelled - De-glue / neutralise

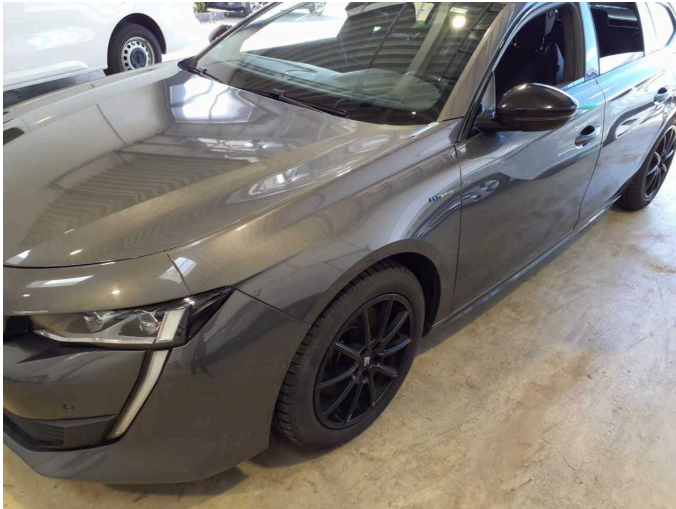
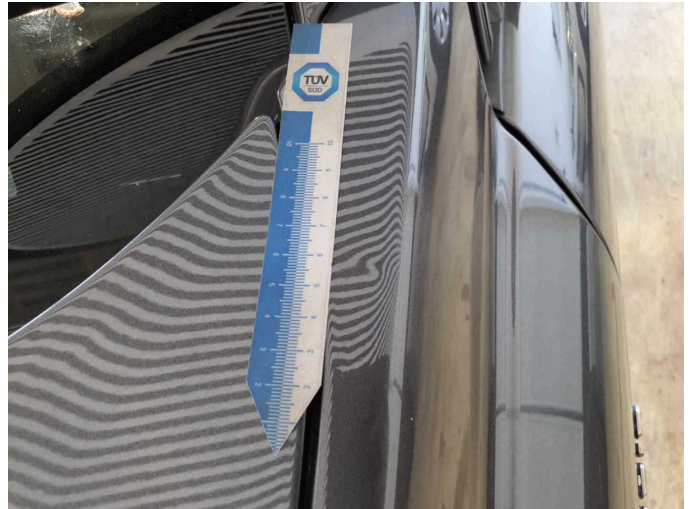
**Damage 5:** Mudguard - left side: Mudguard - left side - dent(s) - Smooth repair work

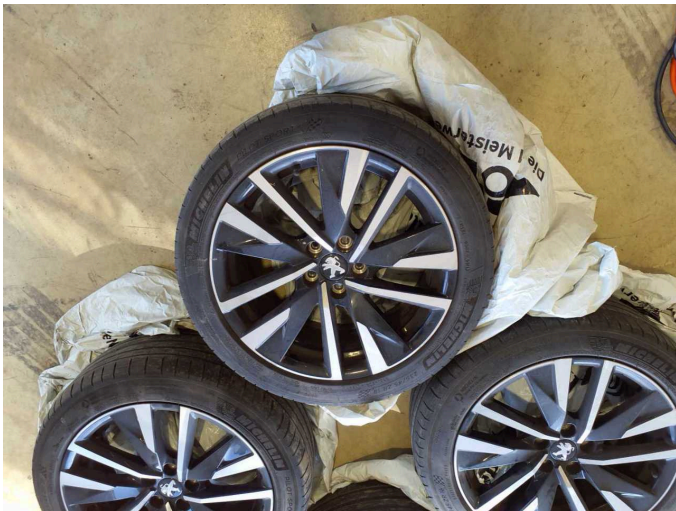
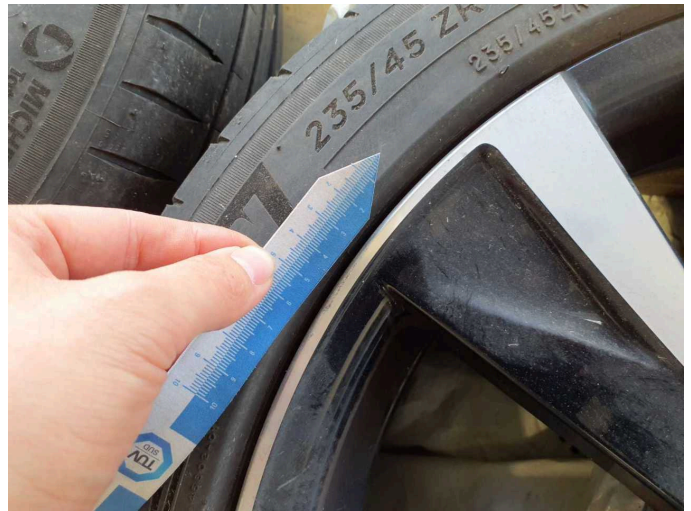
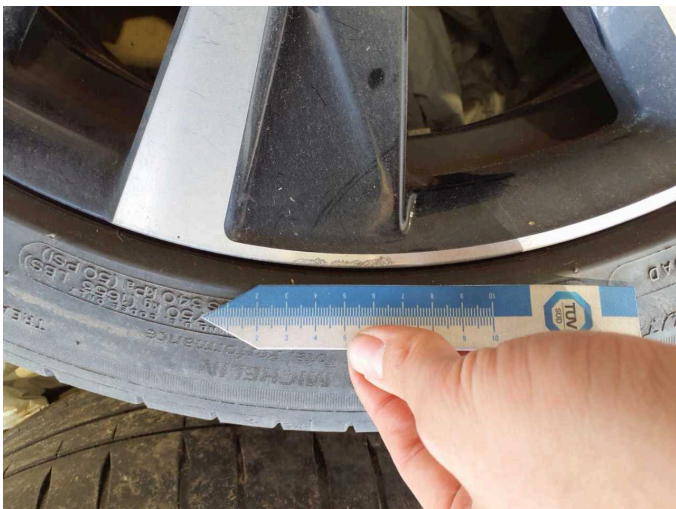
**Damage 6:** 2nd wheel set: 1 alloy rim - Scratch(es) - Loss in value

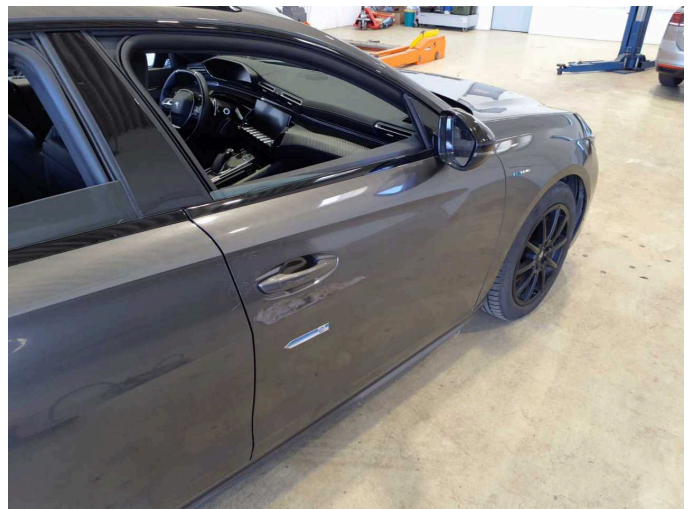
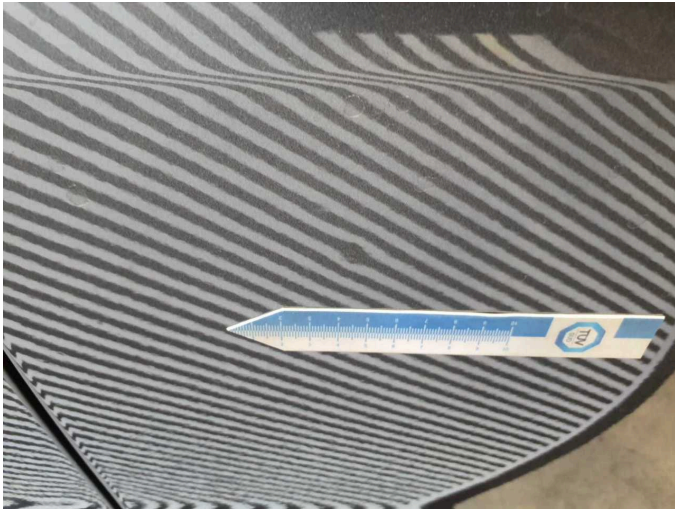
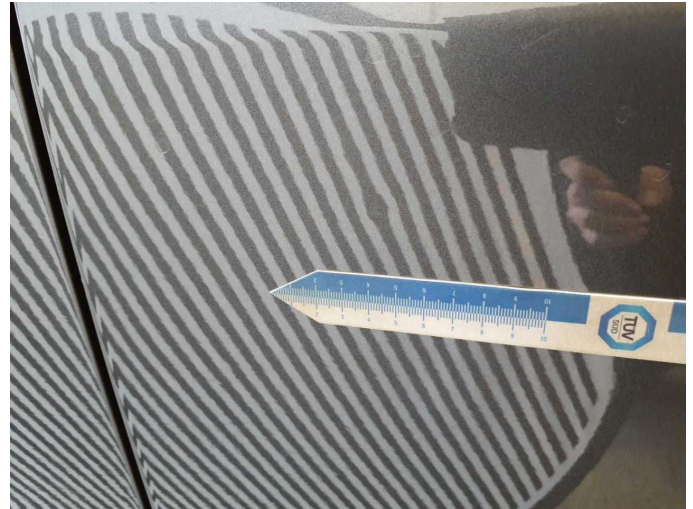
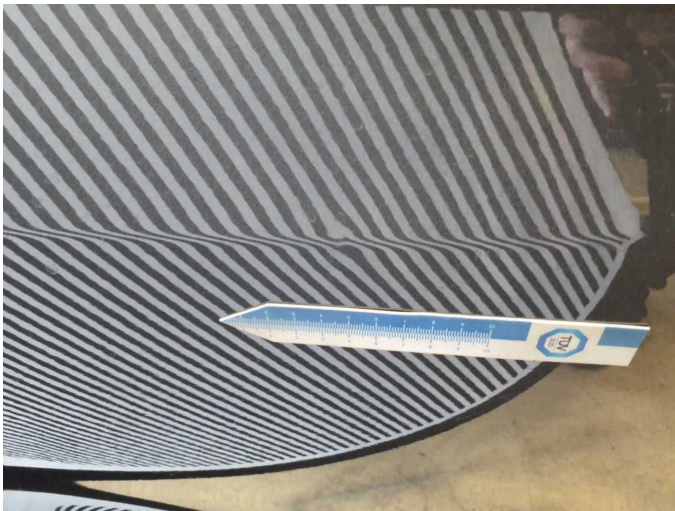
**Damage 7:** Door - front right side: Door - dent(s) - Smart repair

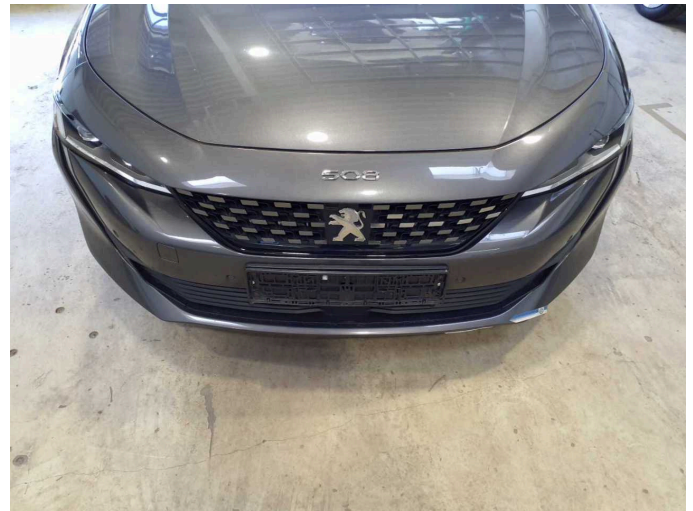
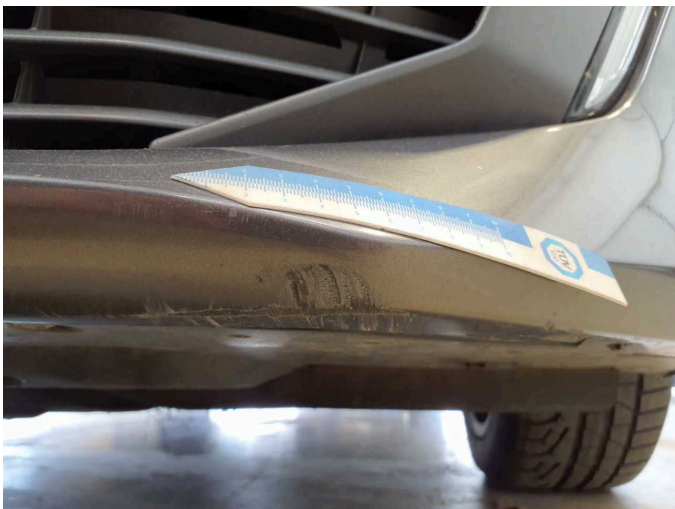
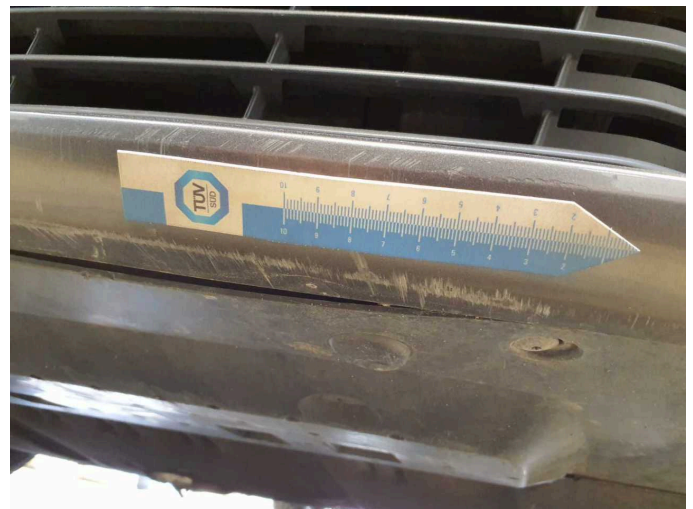
**Damage 8:** Front bumper: Front bumper - Scratch(es) - Smart repair

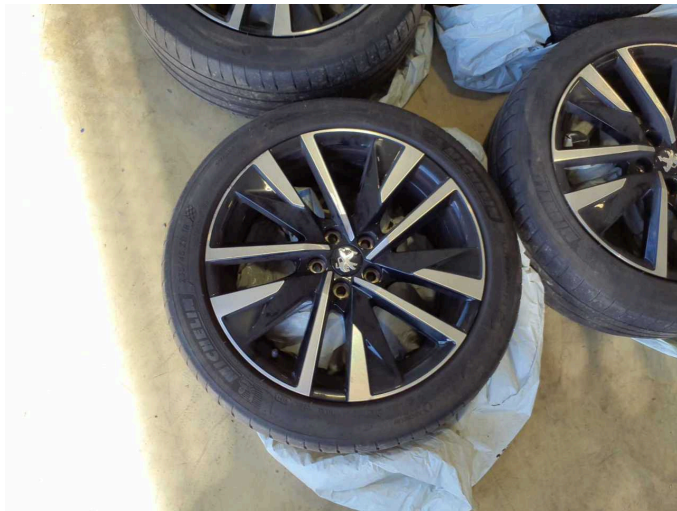
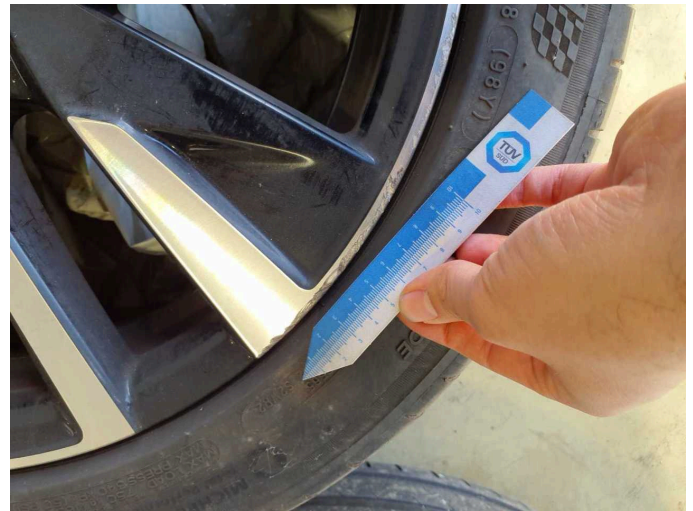
**Damage 9:** 2nd wheel set: 1 alloy rim - Scratched - Loss in value

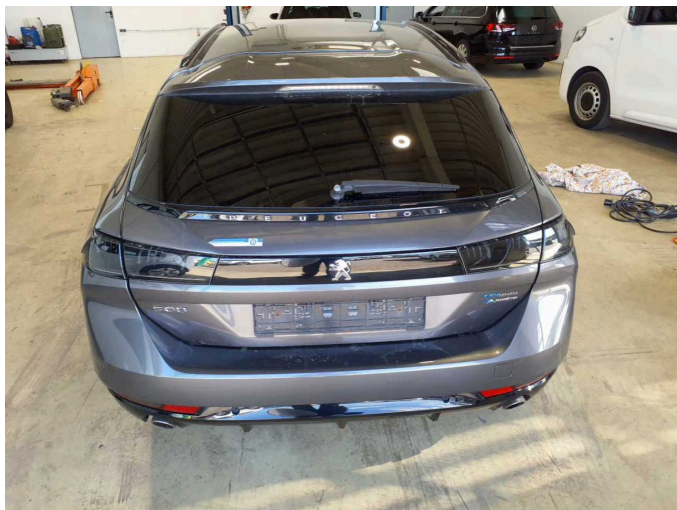
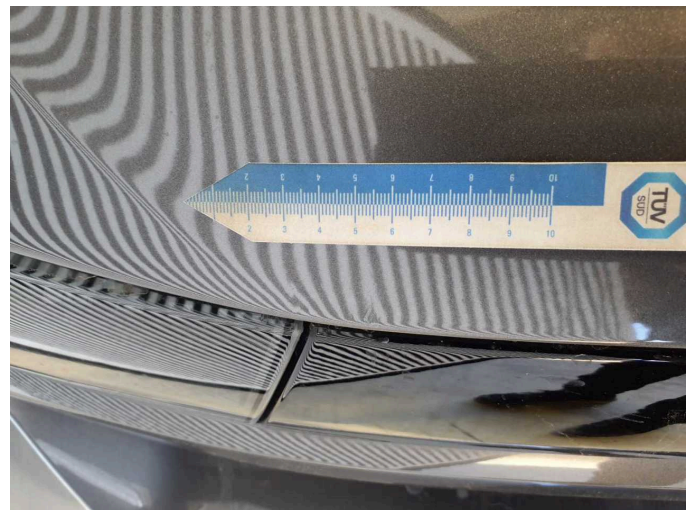
**Damage 10:** Boot lid / rear door: Boot lid - Dent / paintcoat damage - Smart repair

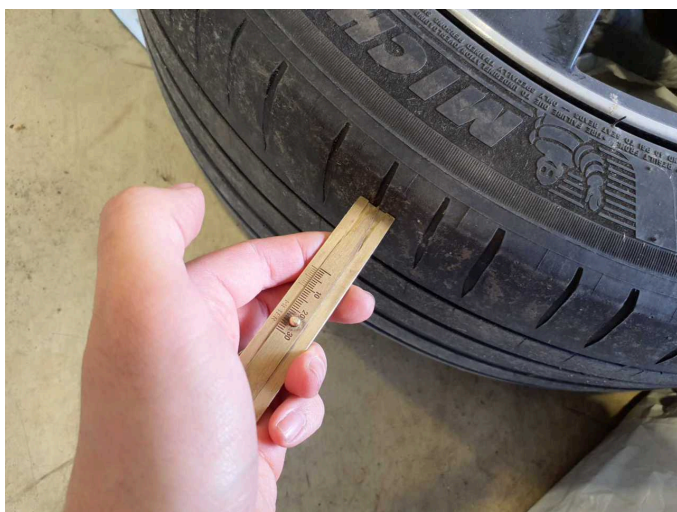
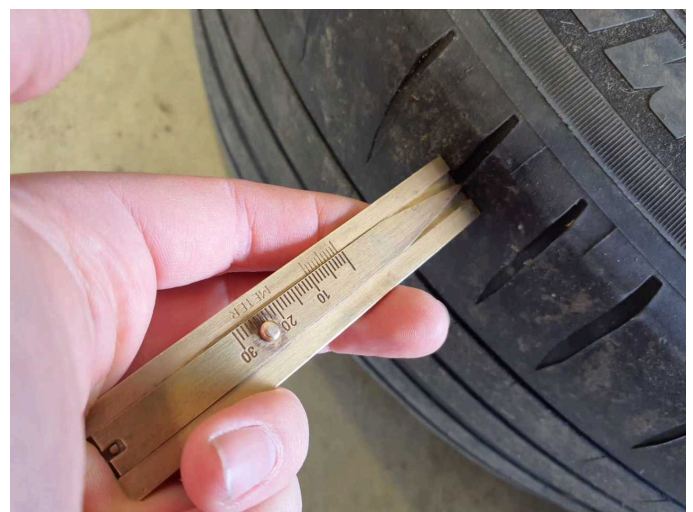
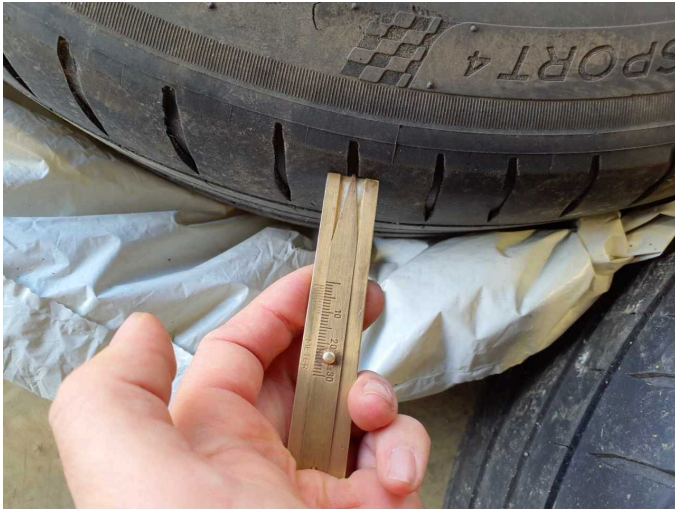
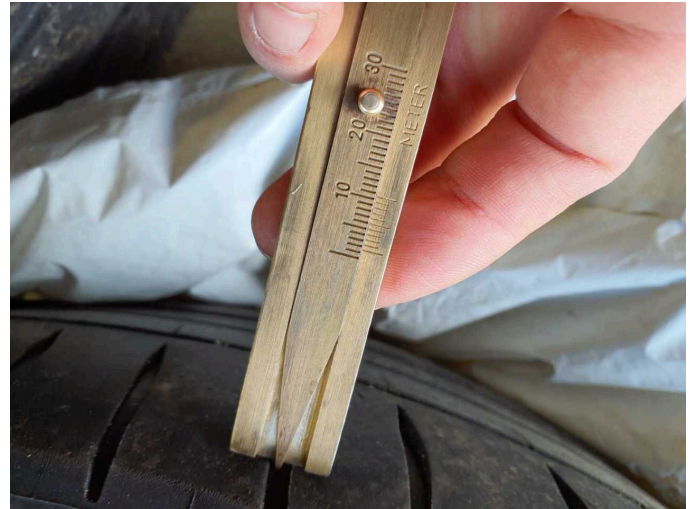
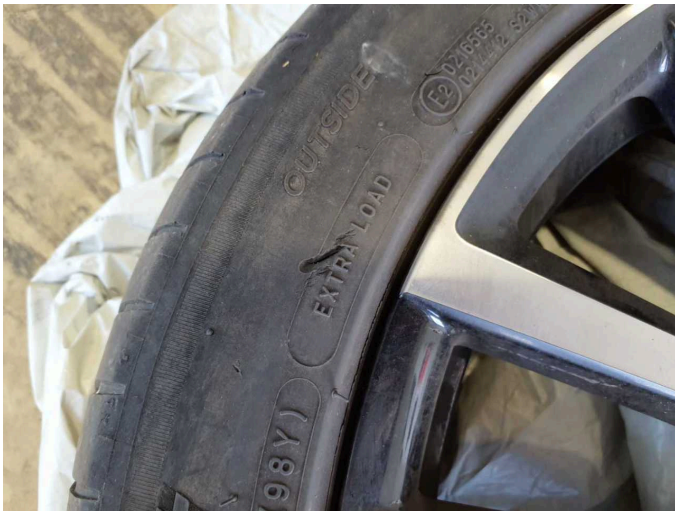
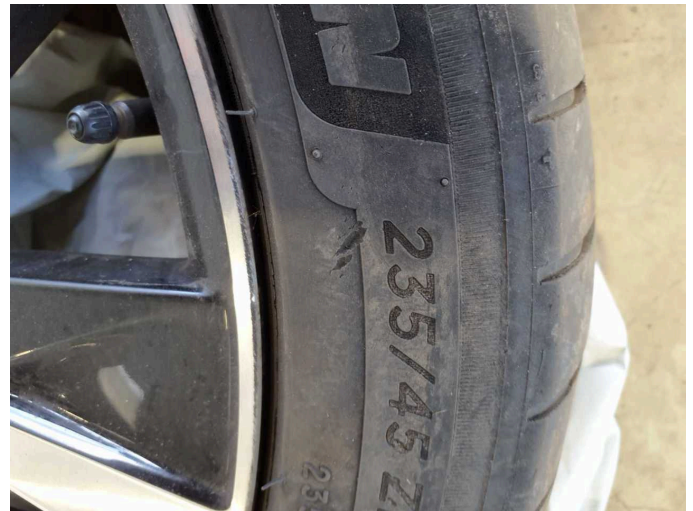
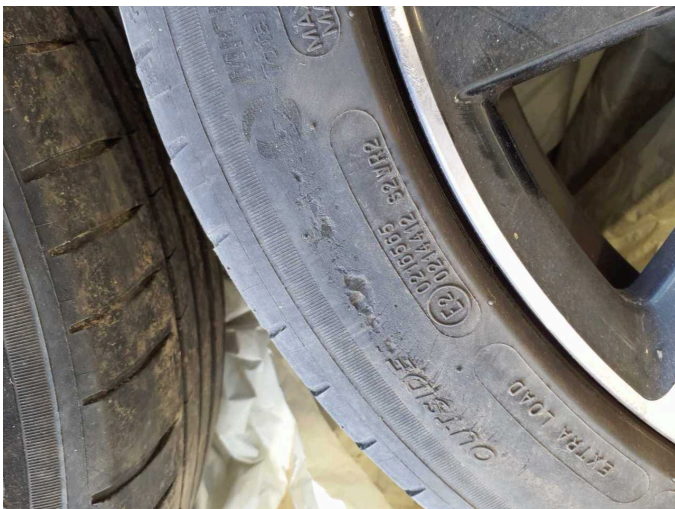
#	Tyre size	Type of tyre	Manufacturer	Tread depth
1)	235/45 R18 98Y	Summer tyres on Light alloy	Michelin	1mm / 1mm
2)	235/45 R18 98Y	Summer tyres on Light alloy	Michelin	3mm / 3mm

**Damage 11:** 2nd wheel set: 2 tyres - Does not meet the leasing specifications - Replace

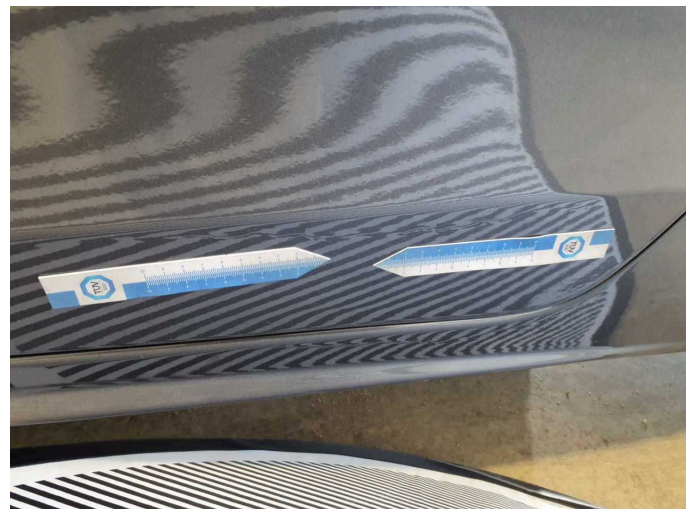
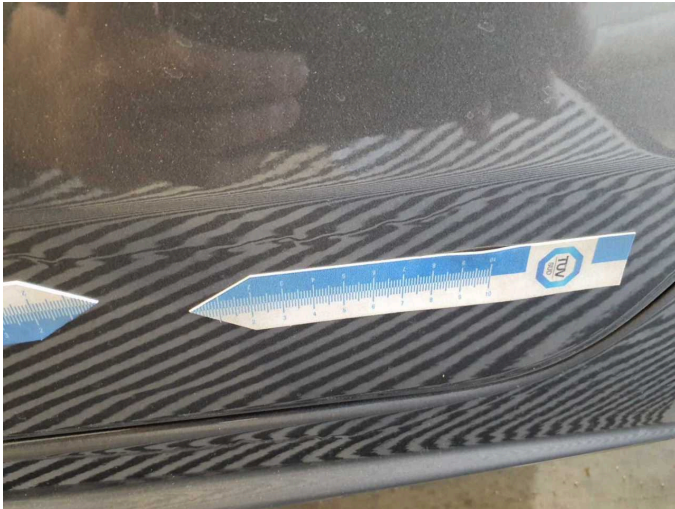
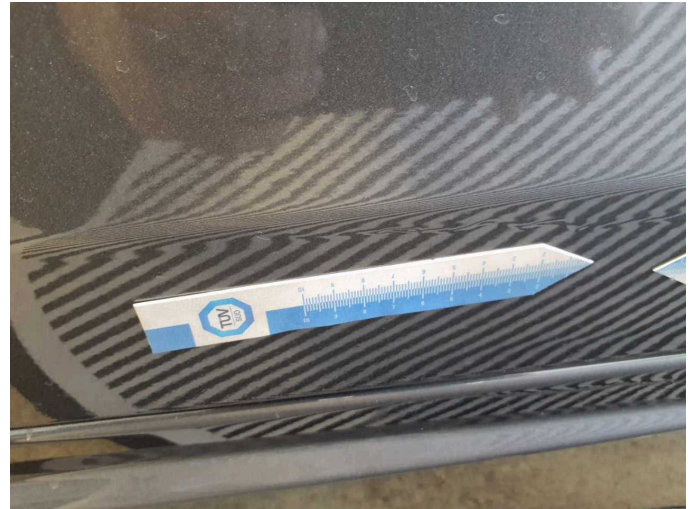
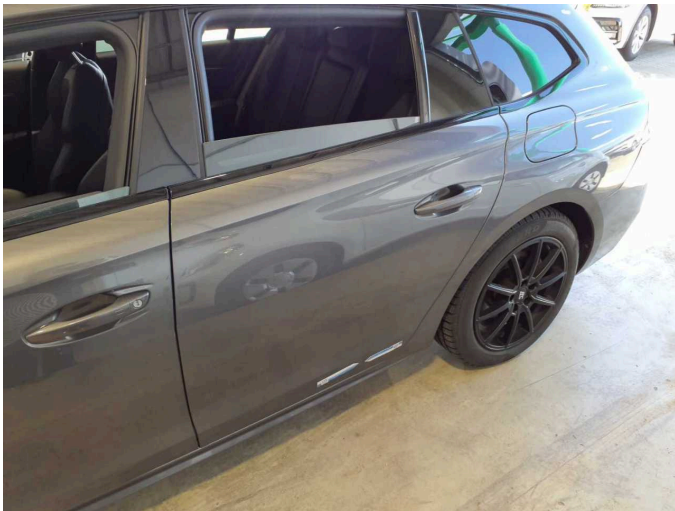
- 1 Side panel - rear left side, Door - front left side, Professionally carried out
- 2 Bumper rear, Unprofessionally carried out
- 3 Door - rear left side, Unprofessionally carried out

Side panel - rear left side	815 µm	Door - rear left side	170 µm
Door - front left side	187 µm

**Damage 12:** Door - rear left side: Door (Läufer) - Unprofessionally repaired - Repair and paint

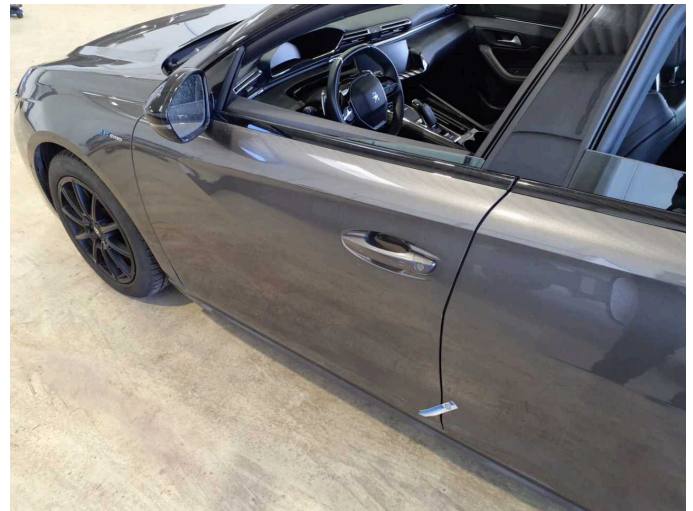
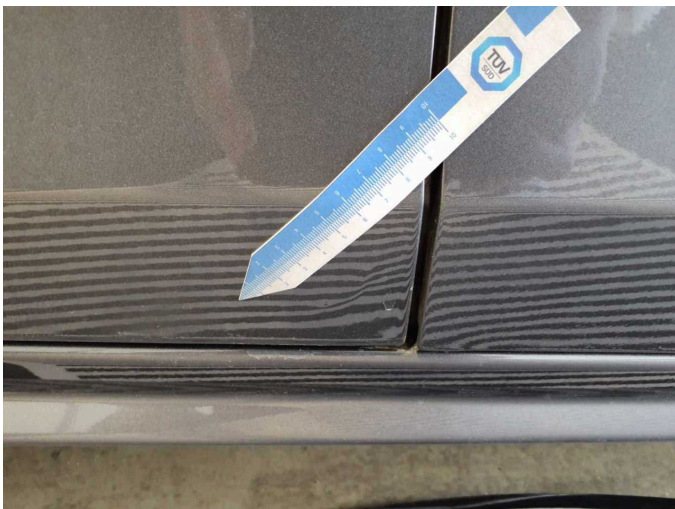
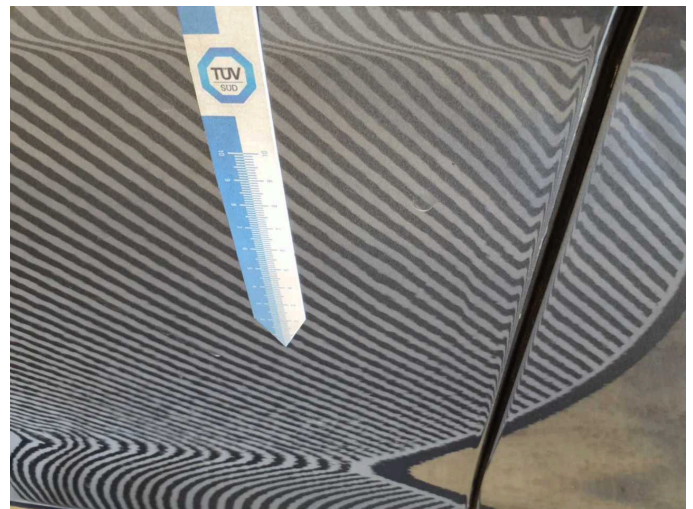
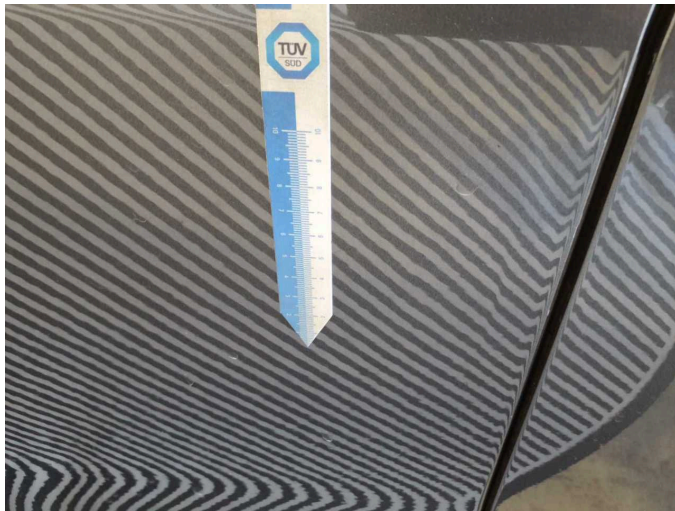
**Damage 13:** Door - front left side: Door - Deformed - Repair and paint

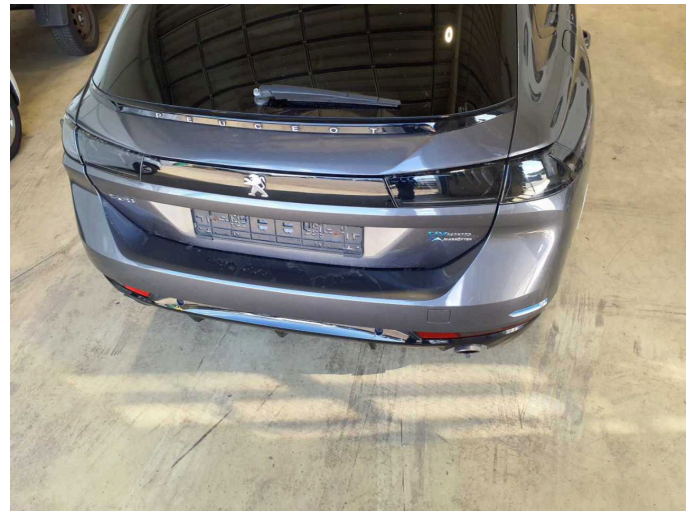
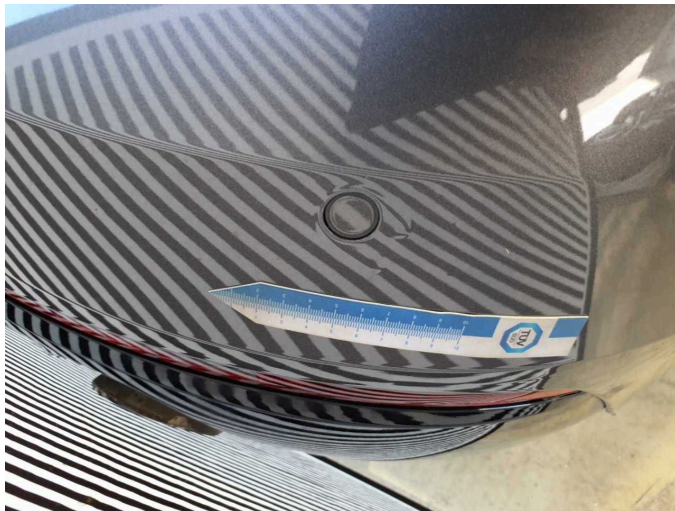
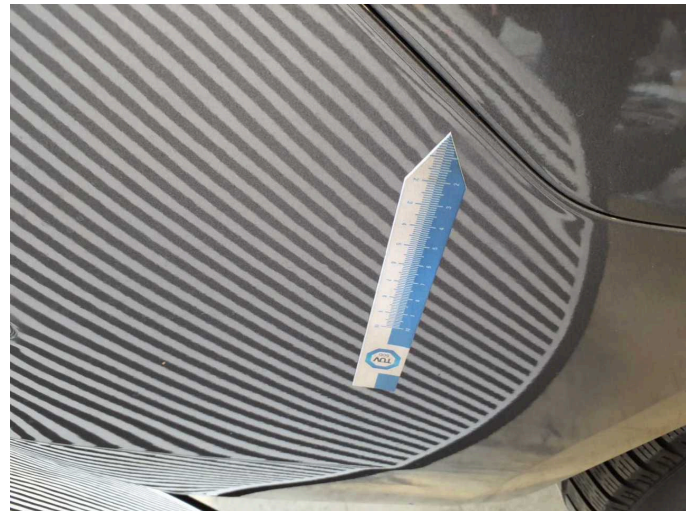
**Damage 14:** Rear bumper: Rear bumper (Weilig und Dellen) - Unprofessionally repaired - Repair and paint

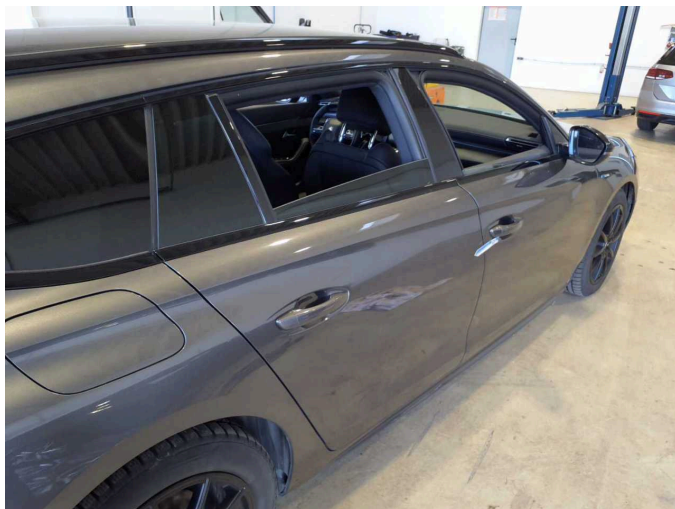
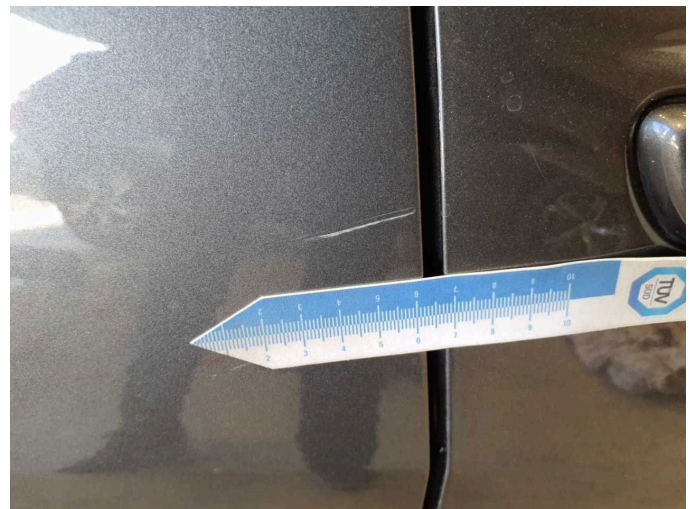
**Damage 15:** Door - rear right side: Door - Scratch(es) - Paint

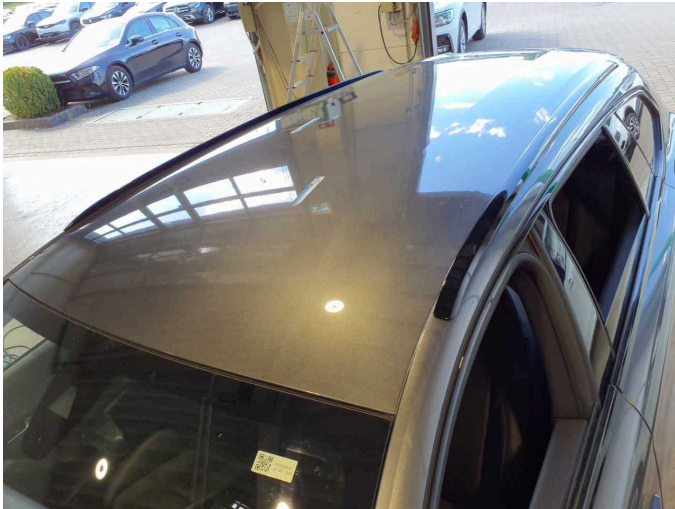
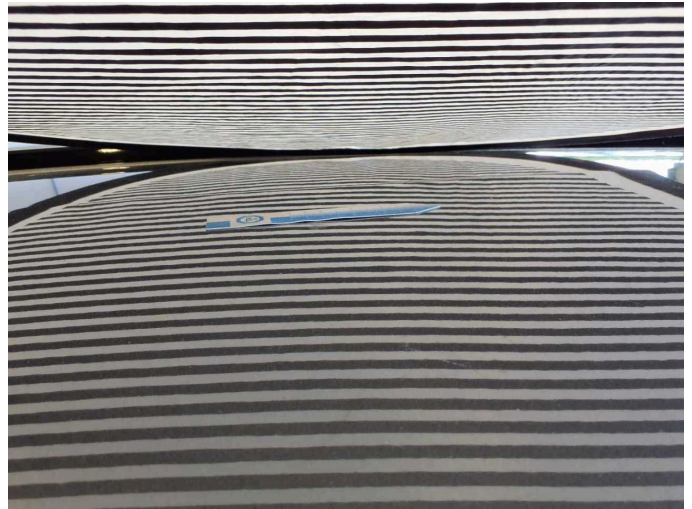
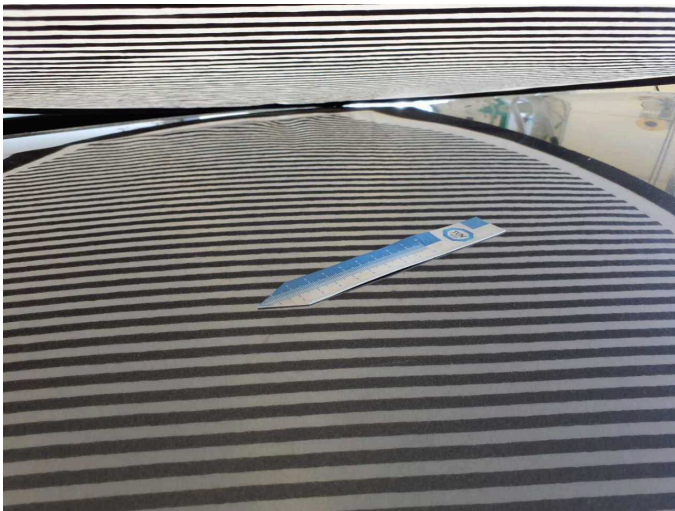
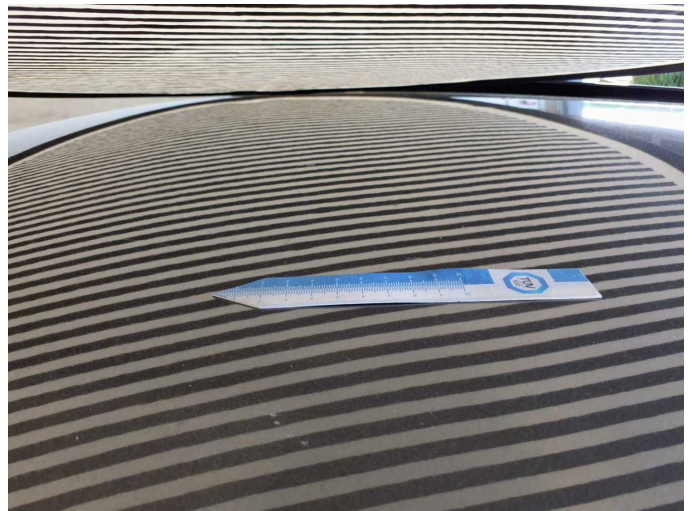
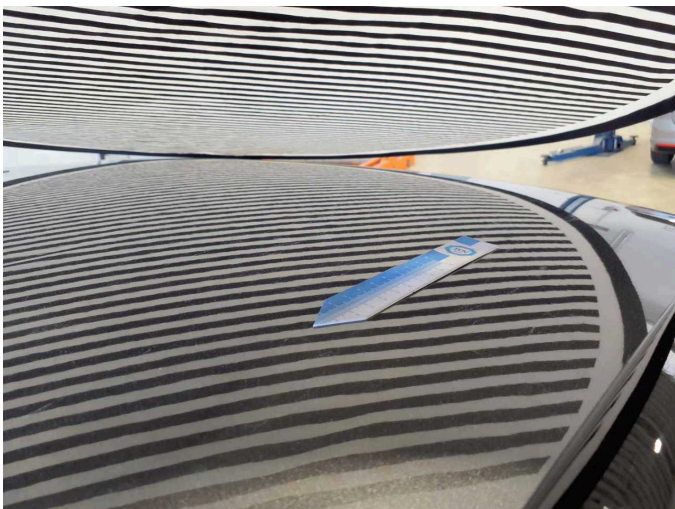
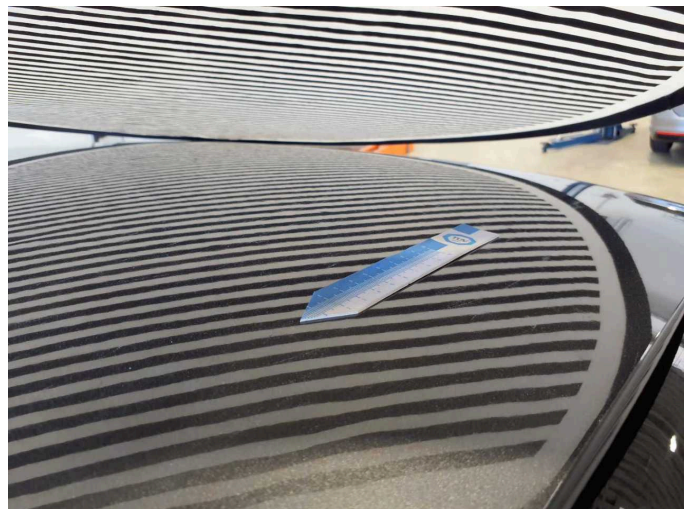
**Damage 16:** Body: Body - Damage by hail - Smooth repair work

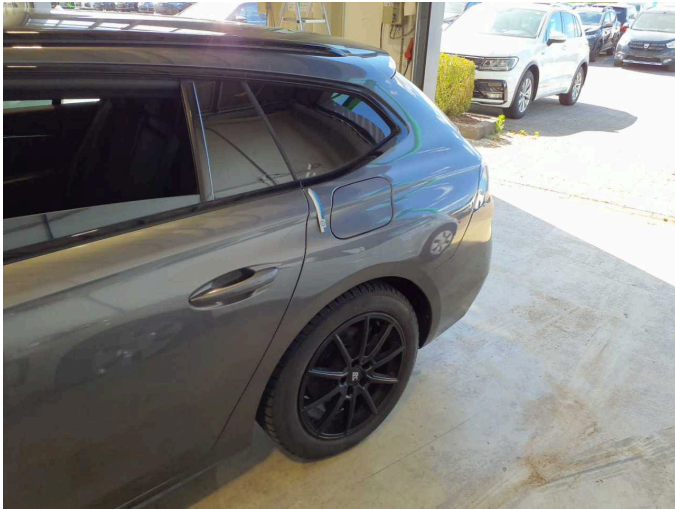
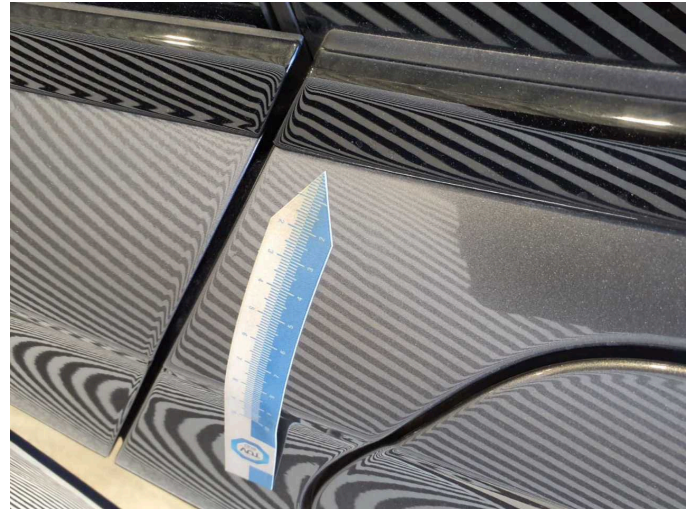
**Wear and tear 5:** Side panel - rear left side: Side panel - dent(s) - No deduction

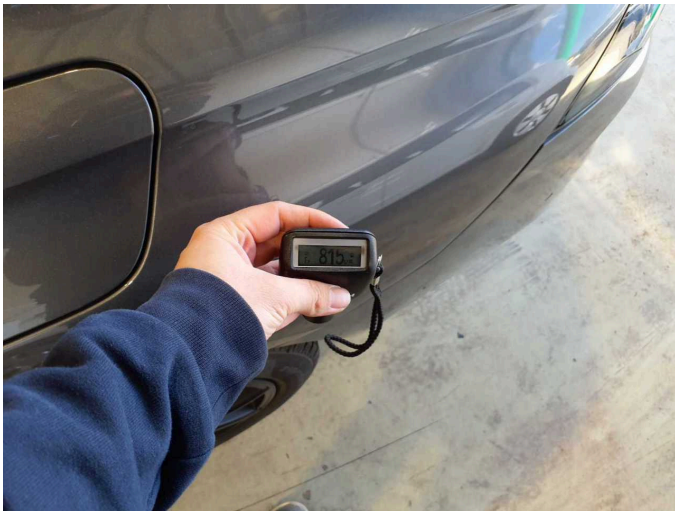
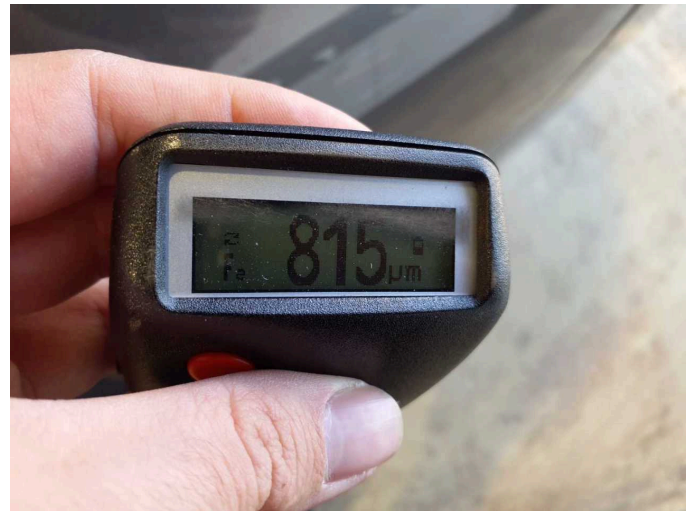
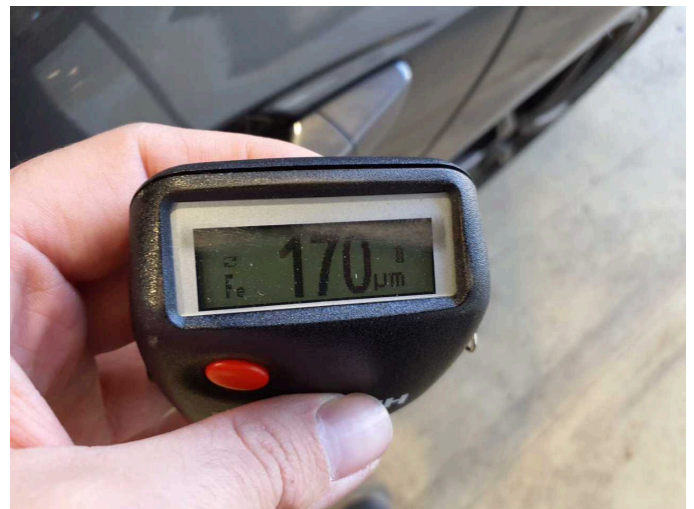
**Repainting 1:** Side panel - rear left side, Door - front left side
