VEHICLE INSPECTION REPORT

1001843976

VSSZZZKJZNR066625

Arona Style 1.0 TSI 81kW 7-speed automatic 4 doors

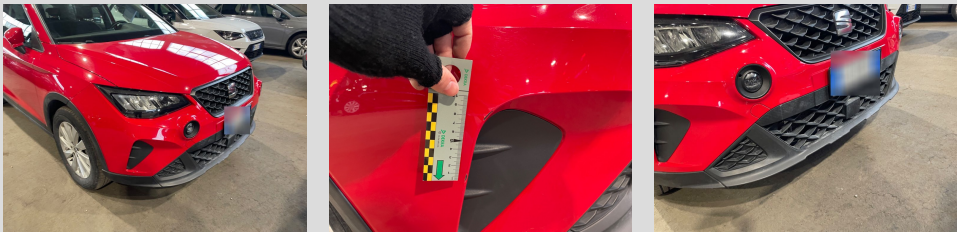
2

Component

Front bumper

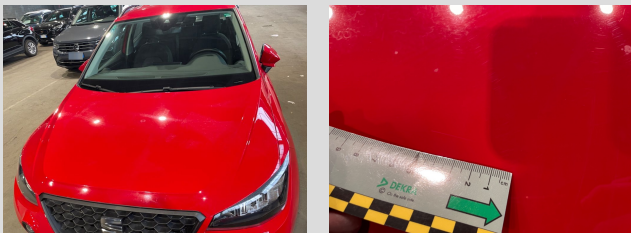
4

Component

Front lid

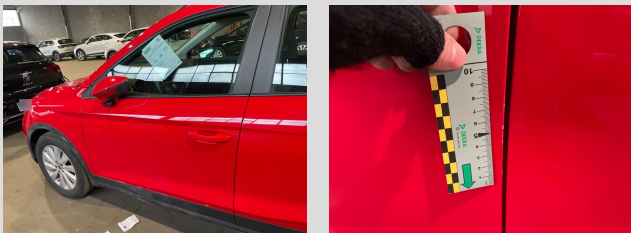
5

Component

Front door

Side

Left
