Expertise

Protocol number: 39426372  
Order No. / Reference: 24710334  
Inspection date: 19 Apr 2025

Manufacturer: Audi

Model: A5 Sportback 35 TDI S tronic

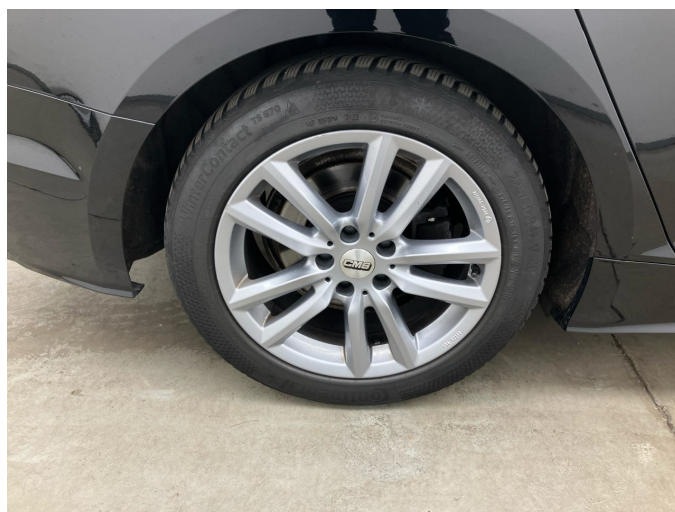
Figure 12: Mounted tyres

#	Tyre size	Type of tyre	Manufacturer	Tread depth
1)	225/50 R17 98V	Winter tyres on Light alloy	Continental	5mm / 5mm
2)	225/50 R17 98V	Winter tyres on Light alloy	Continental	5mm / 5mm

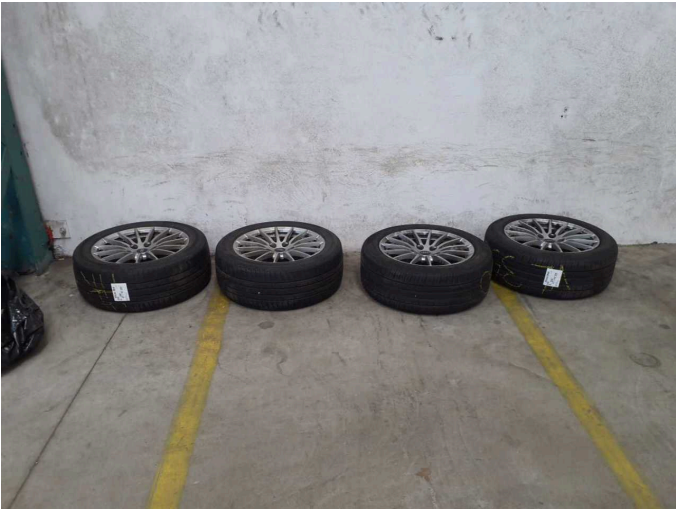
Figure 15: Additional tyres

#	Tyre size	Type of tyre	Manufacturer	Tread depth
1)	225/50 R17 98Y	Summer tyres on Light alloy	Pirelli	5mm / 5mm
2)	225/50 R17 98Y	Summer tyres on Light alloy	Pirelli	5mm / 5mm

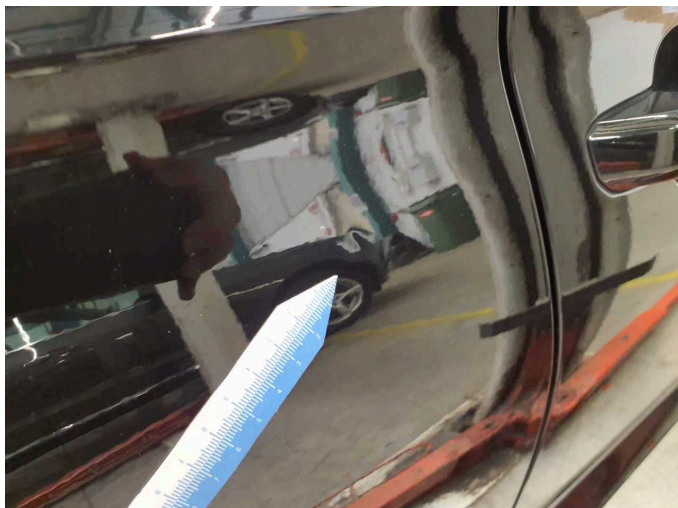
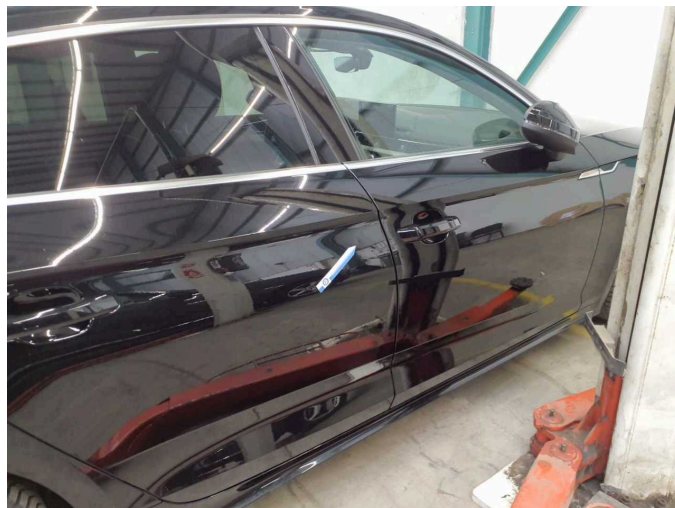
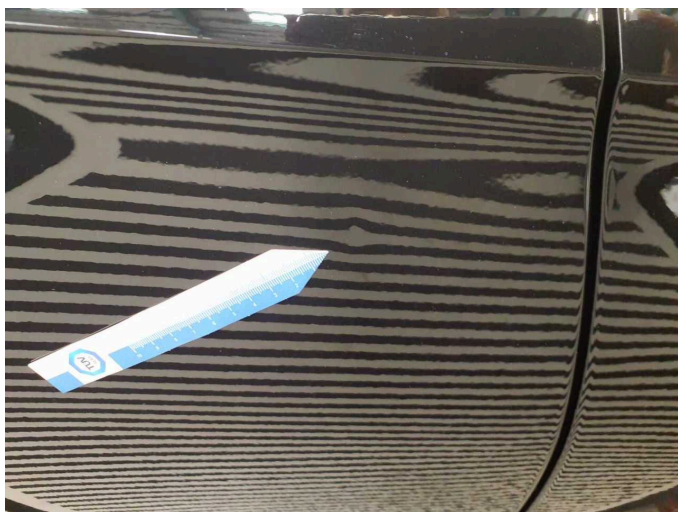
**Damage 1:** Door - rear right side: Door - dent(s) - Smooth repair work

No.	Component group	Description
1	Door - rear right side	Door - dent(s) - Smooth repair work
2	Door - rear left side	Door edge - Scratch(es) - Smart repair

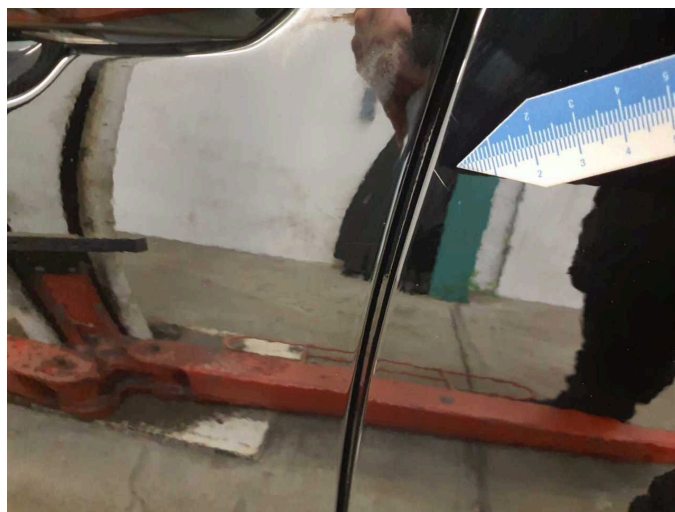
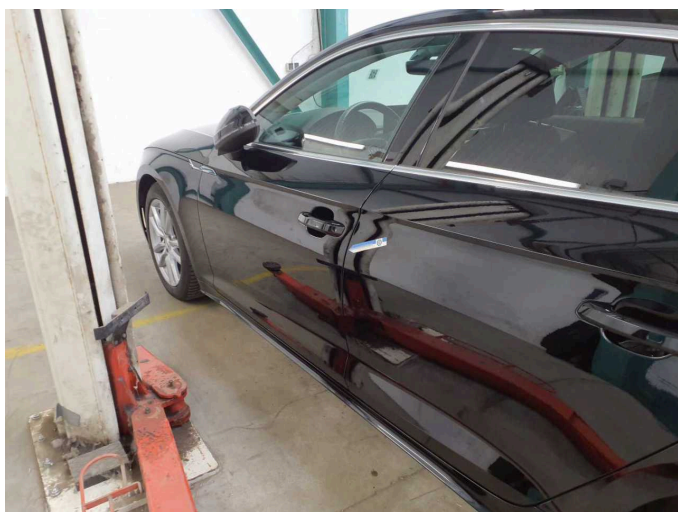
**Damage 2:** Door - rear left side: Door edge - Scratch(es) - Smart repair
