OPEL Corsa: 2CKW001

Limited Technical Inspection

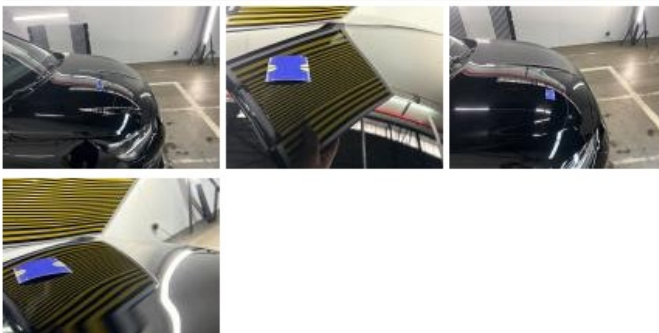
Door panel FR, Scratch(es), Acceptable

Bumper F, Bad repair, Repair and paint (complete)

Bonnet, Dent(s), Paintless dent repair

Door FL, Bad repair, Spot repair

Wing RL, Bad repair, Spot repair

Wing FL, Dent(s), Acceptable

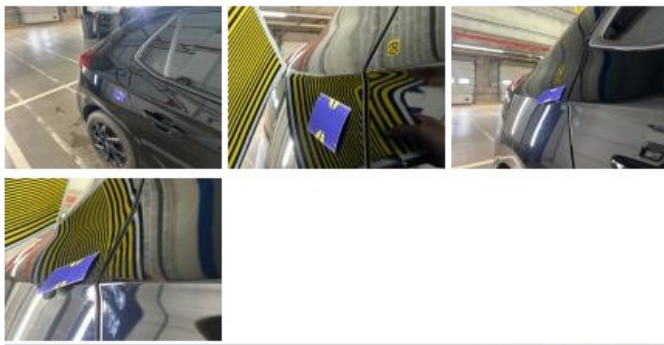
Bumper R, Dent(s), Acceptable

Door FR, Dent(s), Paintless dent repair

Door RR, Dent(s), Spot repair

Wing RR, Dent(s), Acceptable

Roof, Dent(s), Paintless dent repair
