Expertise

Protocol number: 39745791  
Order No. / Reference: 24606927  
Inspection date: 15 May 2025

Manufacturer: Peugeot	Model: 508 SW Hybrid 225 e-EAT8 GT
VIN: VR3F4DGZTMY551925

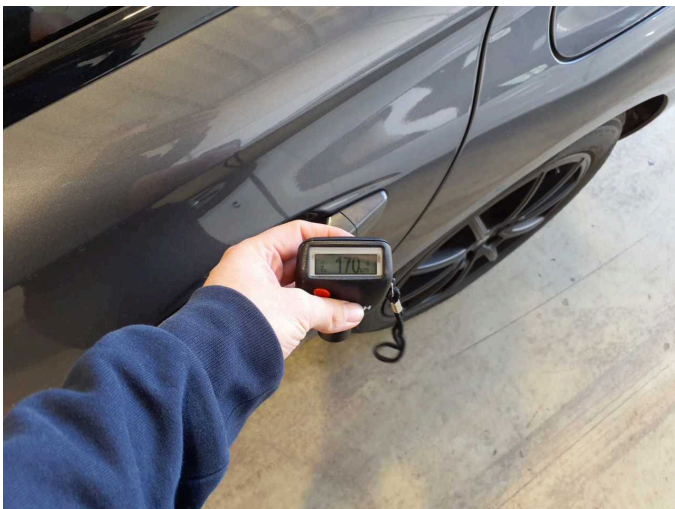
**Repainting 1:** Side panel - rear left side, Door - front left side

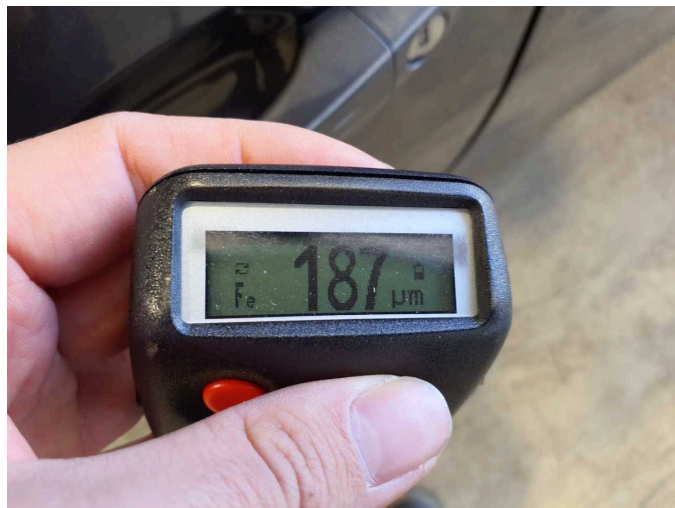
**Repainting 1:** Side panel - rear left side, Door - front left side
